BOISE CITY AREA OF CITY IMPACT
WINDSHIELD SURVEY OF HISTORIC RESOURCES

August 1992

By Donna Hartmans

For Ada County Historic Preservation Council
and
Boise City Historic Preservation Council

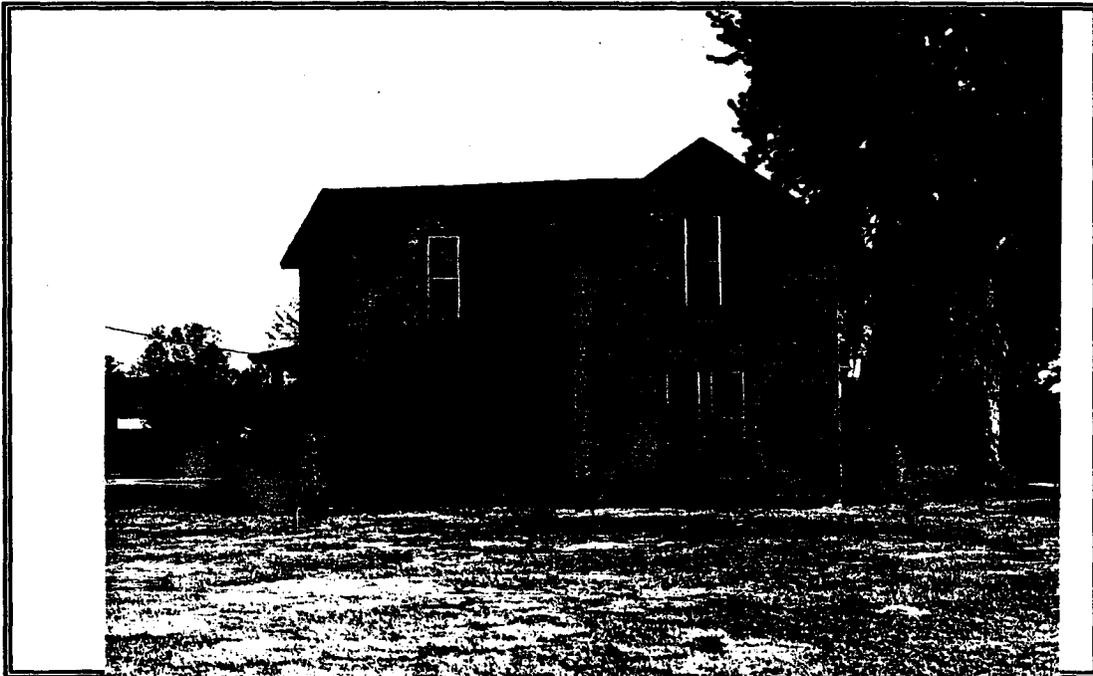
Photo 01/01-02

1. Inventory # 001
2. Historic and/or common name (if known) _____
3. Address of resource northwest corner of Ustick Road and Frontier Way
4. Township Survey Data
SW 1/4 of SE 1/4 of SE 1/4 of Section 34 T4N R1E Boise-Meridian
5. Use/type classification Domestic
6. General Architectural description farm house - wood frame, 2 story, intersecting gable roofs, gable dormer. Rustic siding with cornerboards, watertable, and rakeboards. 1/1 double hung windows. Outbuildings: gable roofed garage to the north.
7. Condition of Resource good - porch altered
8. National Register status (estimation) possibly eligible - district
9. Comments (including degree of development pressure and type on resource) Residential subdivision to north and east encroaches on property. Zoned R8. Under pressure with potential threat.

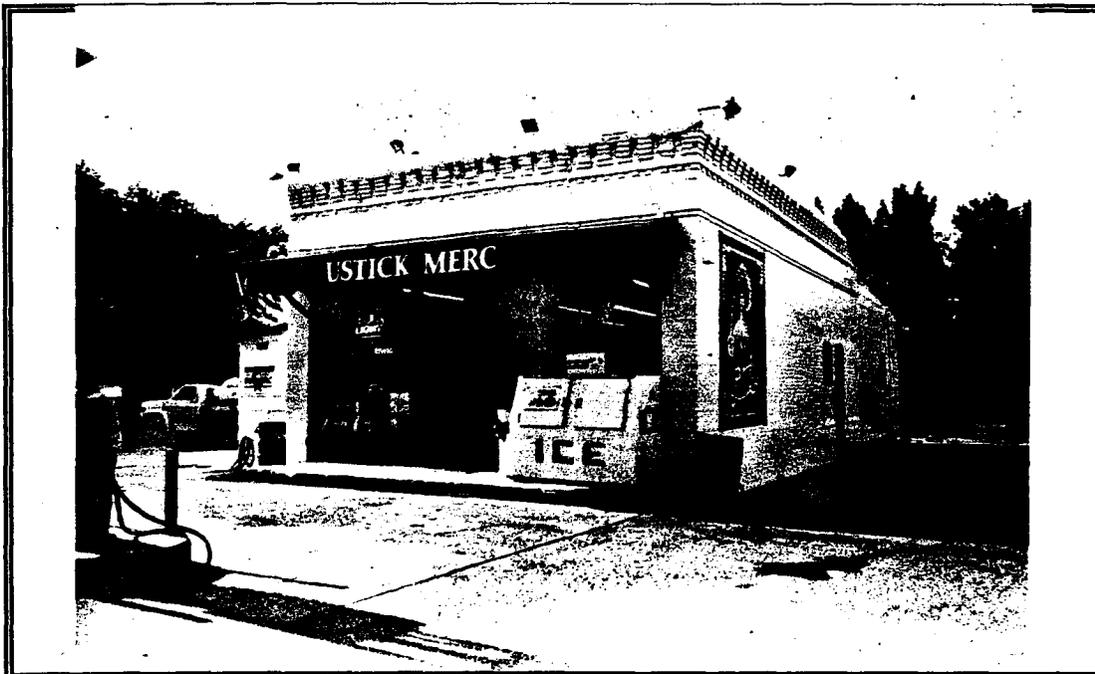
1. Inventory # 002
2. Historic and/or common name (if known) Ustick Merc (?)
3. Address of resource 11355 Ustick Road
4. Township Survey Data
NW 1/4 of NW 1/4 of NE 1/4 of Section 33 T3N R1E Boise-Meridian
5. Use/type classification Commercial
6. General Architectural description 1 story- Painted brick with corbelled cornice. Segmental arches at west door and window. "Pepsi Cola" advertisement painted west elevation on 1 story wood frame additions to east and south. Wood frame outbuilding with gable roof to the southeast
7. Condition of Resource good
8. National Register status (estimation) eligible - district
9. Comments (including degree of development pressure and type on resource) road widening will affect this site - zoned C-2 (Highway Commercial Zone). Under pressure with potential threat.

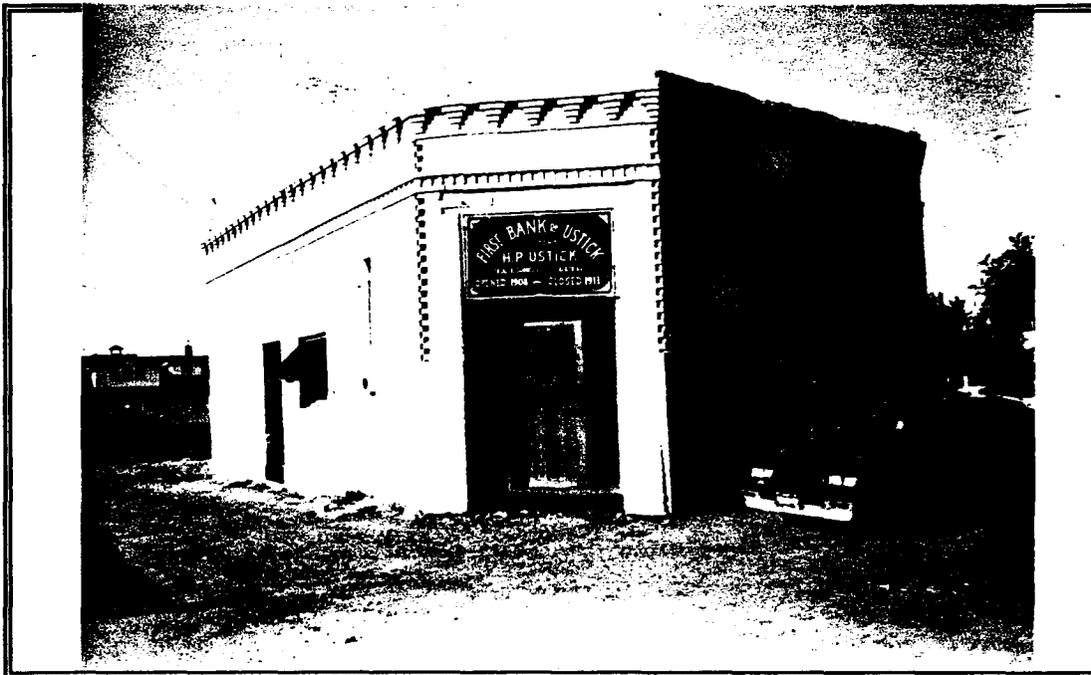
1. Inventory # 003
2. Historic and/or common name (if known) First Bank of Ustick - 1908
3. Address of resource northwest corner Ustick Road and Mumbarto Avenue
4. Township Survey Data
NW 1/4 of NW 1/4 of NE 1/4 of Section 3 T3N R1E Boise-Meridian
5. Use/type classification Commercial, now domestic (?)
6. General Architectural description 1 story, painted brick with corbelled cornice. The doorway and north window have been altered/infilled. Sign above door provides historical information.
7. Condition of Resource Good
8. National Register status (estimation) eligible - district
9. Comments (including degree of development pressure and type on resource) road widening will affect this site - Zoned C-2 (Highway Commercial zone). Under pressure with potential threat.

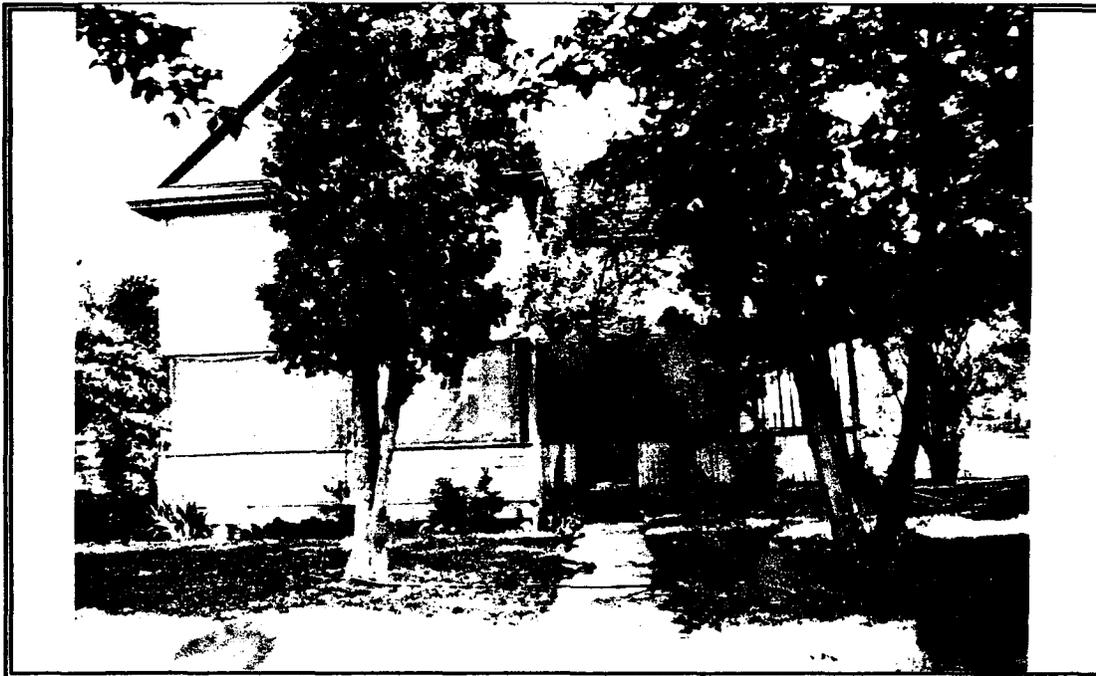
1. Inventory # 004
2. Historic and/or common name (if known) _____
3. Address of resource 11438 Ustick Road
4. Township Survey Data
SW 1/4 of SW 14/ of SE 1/4 of Section 34 T4N R1E Boise-Meridian
5. Use/type classification Residence
6. General Architectural description wood frame, 2 story, rustic siding and decorative gable shingles, cross gable roof with pedimented south gable. Open porch on south and east with turned columns. Multi-paned double hung windows.
7. Condition of Resource Good
8. National Register status (estimation) possibly eligible - district
9. Comments (including degree of development pressure and type on resource) residential subdivision to the north encroaching on pasture area. Road widening may impact the property. Under pressure with potential threats. Zoned R1.

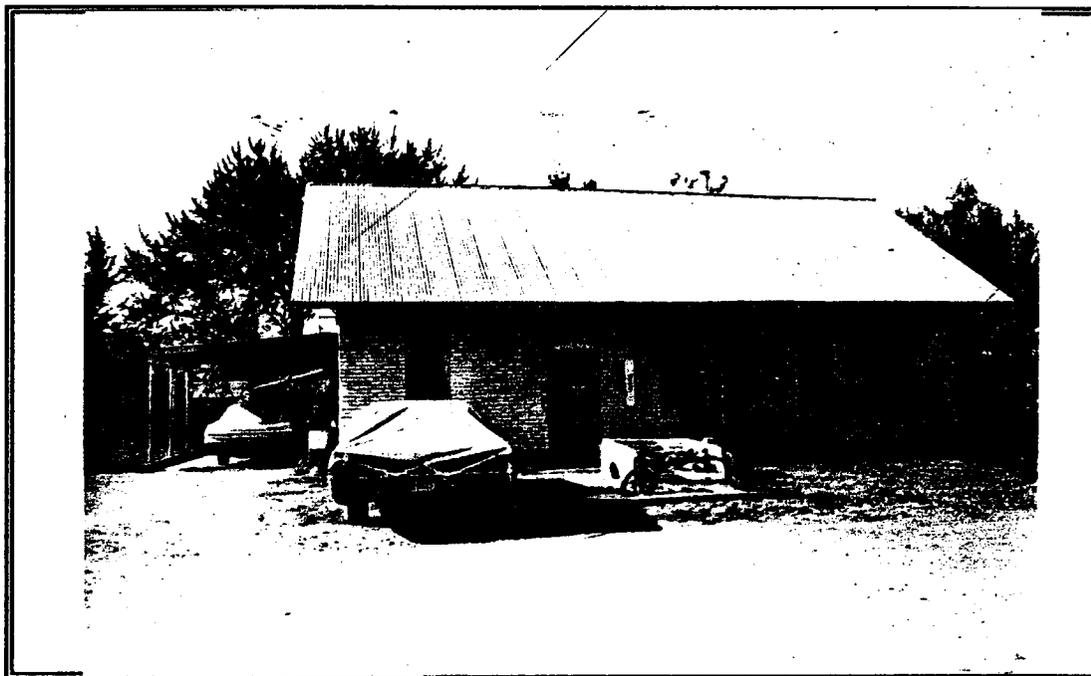
1. Inventory # 005
2. Historic and/or common name (if known) Ustick garage (?)
3. Address of resource 11375 Ustick Road
4. Township Survey Data
NW 1/4 of NW 1/4 of NE 1/4 of Section 3 T3N R1E Boise-Meridian
5. Use/type classification Commercial
6. General Architectural description brick, 1 1/2 story, gable roof with metal roofing. 2/2 double hung windows. Segmental arches at windows and doors. Carport addition at east. Rear (south) wood frame residence addition.
7. Condition of Resource Good
8. National Register status (estimation) possibly eligible - district
9. Comments (including degree of development pressure and type on resource) minimal recent development around site. Road widening will affect this property. Zoned C-2 (Highway Commercial) Under pressure with potential threat.

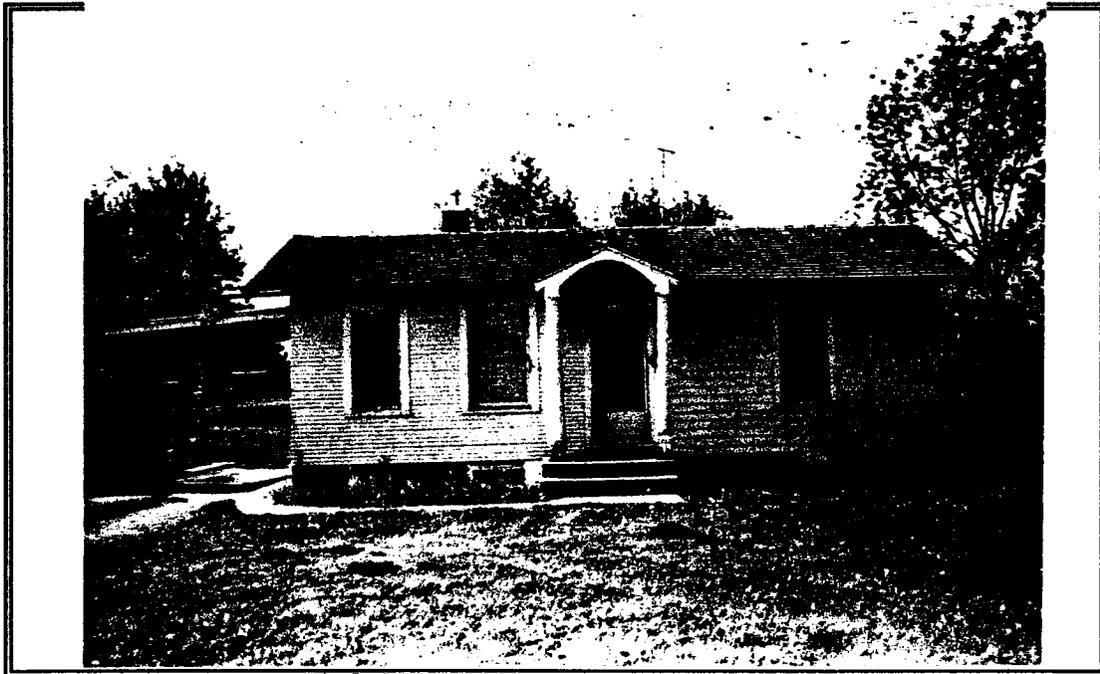
1. Inventory # 006
2. Historic and/or common name (if known) _____
3. Address of resource 11397 Ustick Road
4. Township Survey Data
NW 1/4 of NW 1/4 of NE 1/4 of Section 3 T3N R1E Boise-Meridian
5. Use/type classification Domestic
6. General Architectural description 1 story, wood frame, gable roof, cinder block foundation; projecting porch gable with vaulted ceiling and tuscan columns. Wide bevel lap siding to the west and narrow lap siding to the east. 1/1 double hung windows. Carport addition to the east, and rear (south) addition. Shed located to the east of the carport.
7. Condition of Resource Fair
8. National Register status (estimation) possibly eligible - district
9. Comments (including degree of development pressure and type on resource) Road widening would be an impact to this property. Zoned C-2 (Highway Commercial Zone). Under pressure with potential threat.

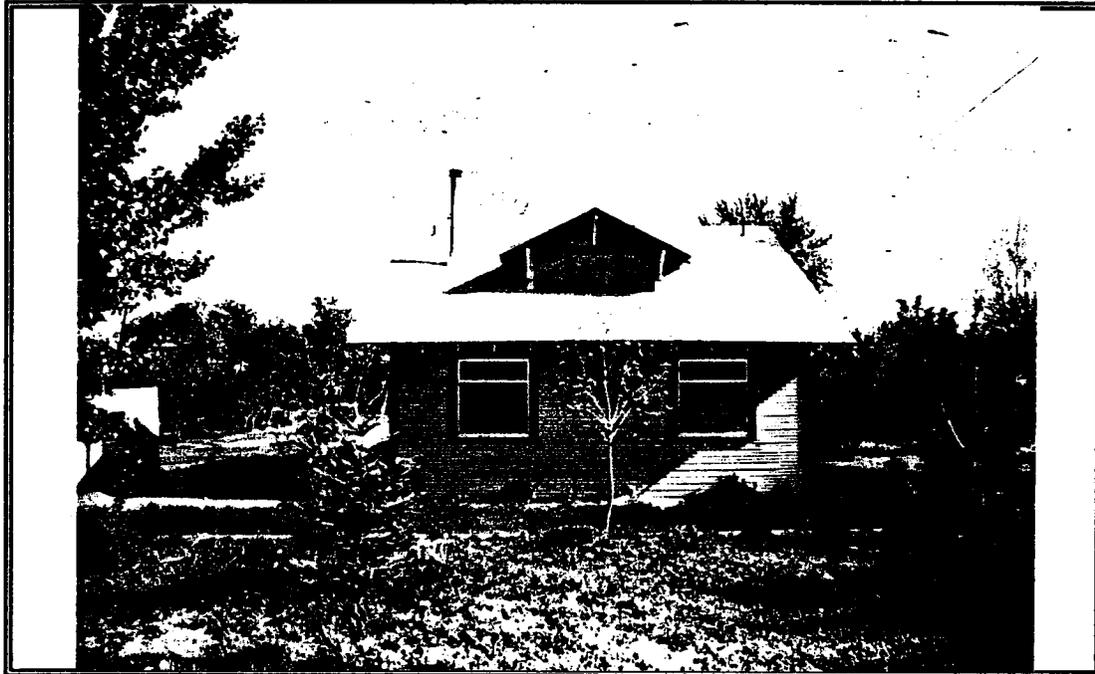
1. Inventory # 007
2. Historic and/or common name (if known) _____
3. Address of resource 11690 Ustick Road
4. Township Survey Data
SW 1/4 of SE 1/4 of SW 1/4 of Section 34 T4N R1E Boise-Meridian
5. Use/type classification Domestic
6. General Architectural description 1 1/2 story bungalow. Wood frame narrow lap siding, gable roof with exposed rafter ends, decorative brackets. Gable dormer. Fixed windows with leaded glass.
7. Condition of Resource Good
8. National Register status (estimation) possibly eligible - district
9. Comments (including degree of development pressure and type on resource) Road widening will affect this site. Residential subdivision to the north encroaches on property. Zoned R1. Under pressure with possible threat.

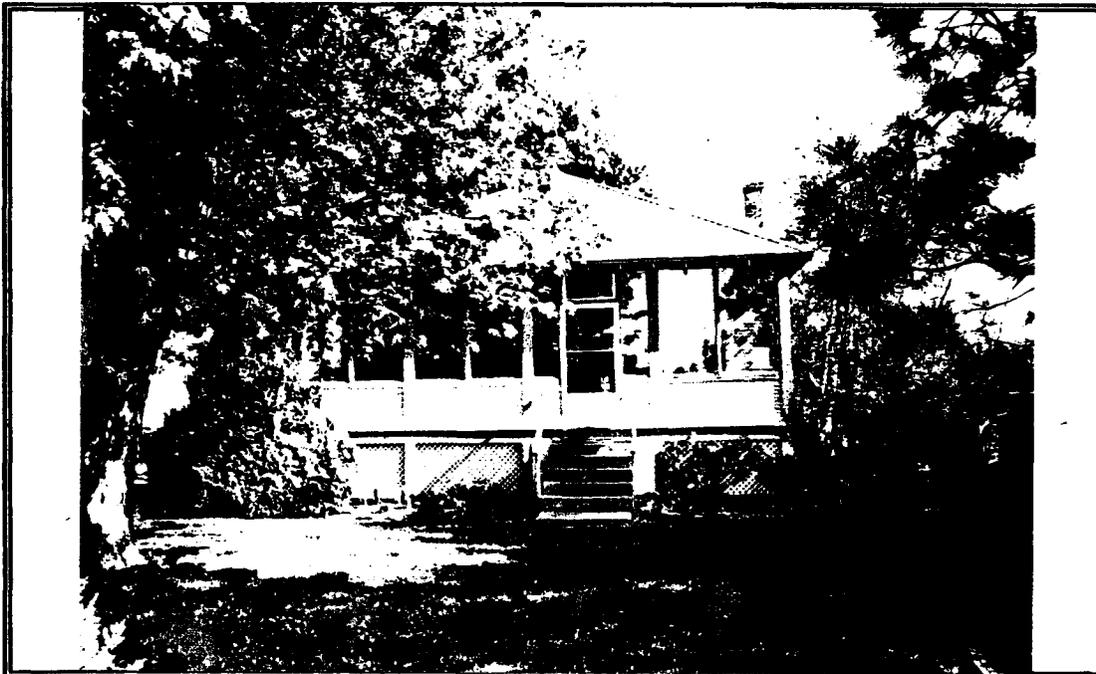
1. Inventory # 008
2. Historic and/or common name (if known) _____
3. Address of resource 11700 Ustick Road
4. Township Survey Data
SW 1/4 of SE 1/4 of SW 1/4 of Section 34 T4N R1E Boise-Meridian
5. Use/type classification Domestic
6. General Architectural description 1 story wood frame, hip roof, exposed rafter ends. Rustic siding. Enclosed porch.
7. Condition of Resource Good
8. National Register status (estimation) possibly eligible - district
9. Comments (including degree of development pressure and type on resource) Road widening will affect this property. Residential subdivision to the north encroaches upon property. Zoned R8. Under pressure with potential threat.

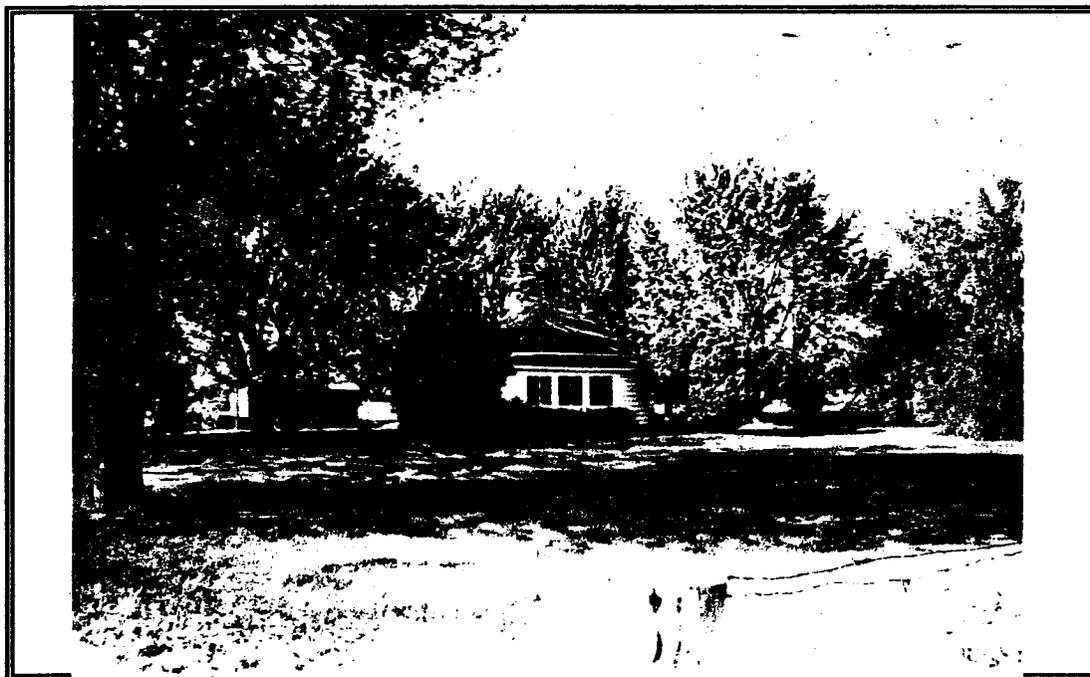
1. Inventory # 009
2. Historic and/or common name (if known) _____
3. Address of resource 12055 Ustick Road
4. Township Survey Data
NW 1/4 of NW 1/4 of NW 1/4 of Section 3 T3N R1E Boise-Meridian
5. Use/type classification Domestic/Agricultural
6. General Architectural description 1 story wood frame house with aluminum siding, hip roof. Enclosed porch at east and north. Windows altered - siding aluminum. Five wood frame outbuildings, 1 metal shed.
7. Condition of Resource Fair
8. National Register status (estimation) unevaluated
9. Comments (including degree of development pressure and type on resource) Residential subdivision to the far east. Agricultural area to the south and west - if developed for residential sites, would impact this site. Zoned AP-2. Under pressure

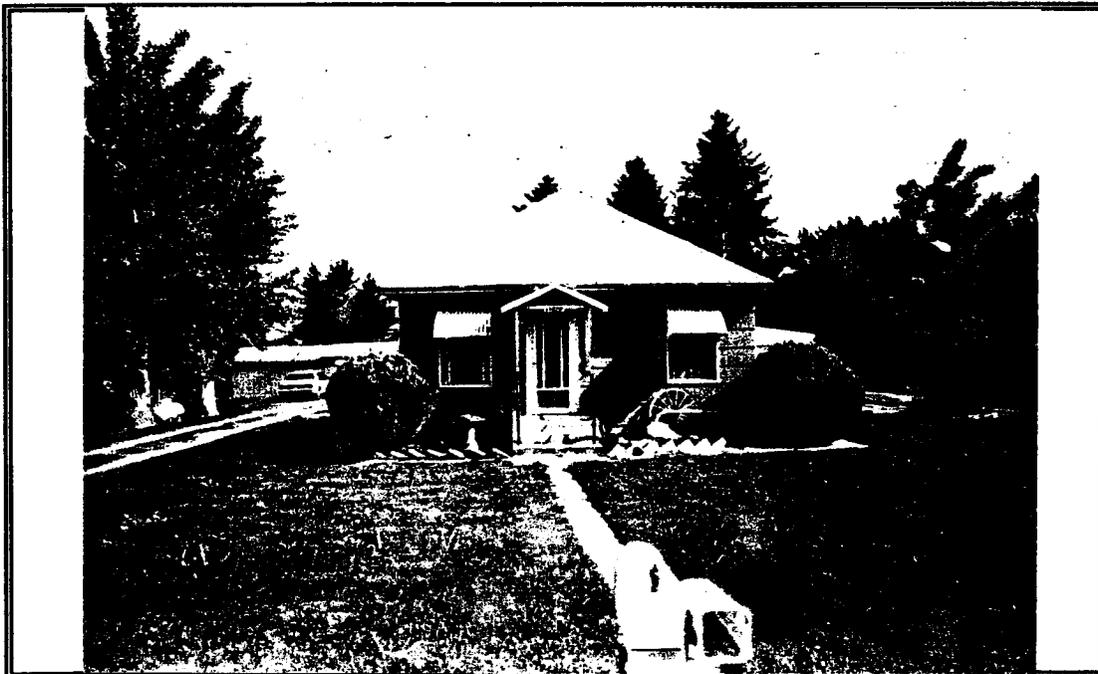
1. Inventory # 011
2. Historic and/or common name (if known) _____
3. Address of resource 11622 Ustick Road
4. Township Survey Data
SW 1/4 of SE 1/4 of SW 1/4 of Section 34 T4N R1E Boise-Meridian
5. Use/type classification Residential
6. General Architectural description 1 story wood frame with hip roof and asbestos siding, windows have been altered. Gable roof supported by brackets over front door. 1 wood frame outbuilding.
7. Condition of Resource Fair
8. National Register status (estimation) not eligible
9. Comments (including degree of development pressure and type on resource) residential subdivision to the north. Road widening will affect this property. Zoned R1. Under pressure with potential threat.

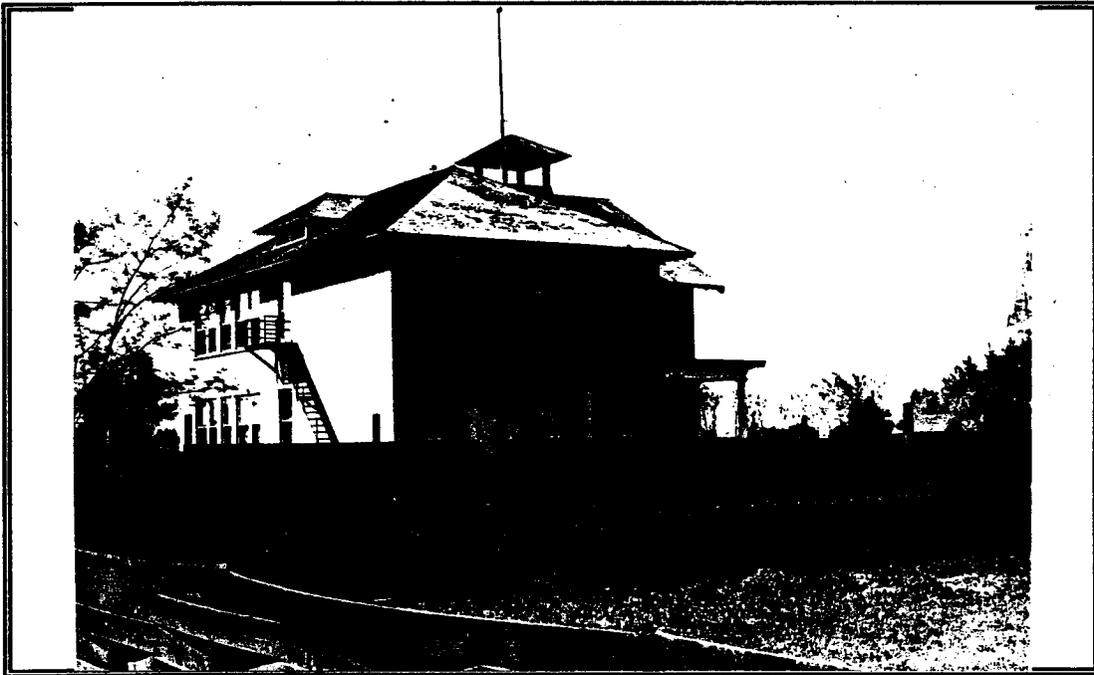
5. Use/type classification School building now residential
6. General Architectural description 2 1/2 story brick school building with cut stone foundation, hip roof with cross gable at west. Exposed rafter ends and bell tower. Entry porch on northwest side has Ionic columns and dentils along the eaves. 1/1 double hung windows.

7. Condition of Resource Good
8. National Register status (estimation) already nominated
9. Comments (including degree of development pressure and type on resource) Potential development of pasture at south for residential sites would impact the site. Zoned R8. Under pressure.
Also see Historic Idaho Buildings Survey 004460 and Ustick School Nomination 011389.

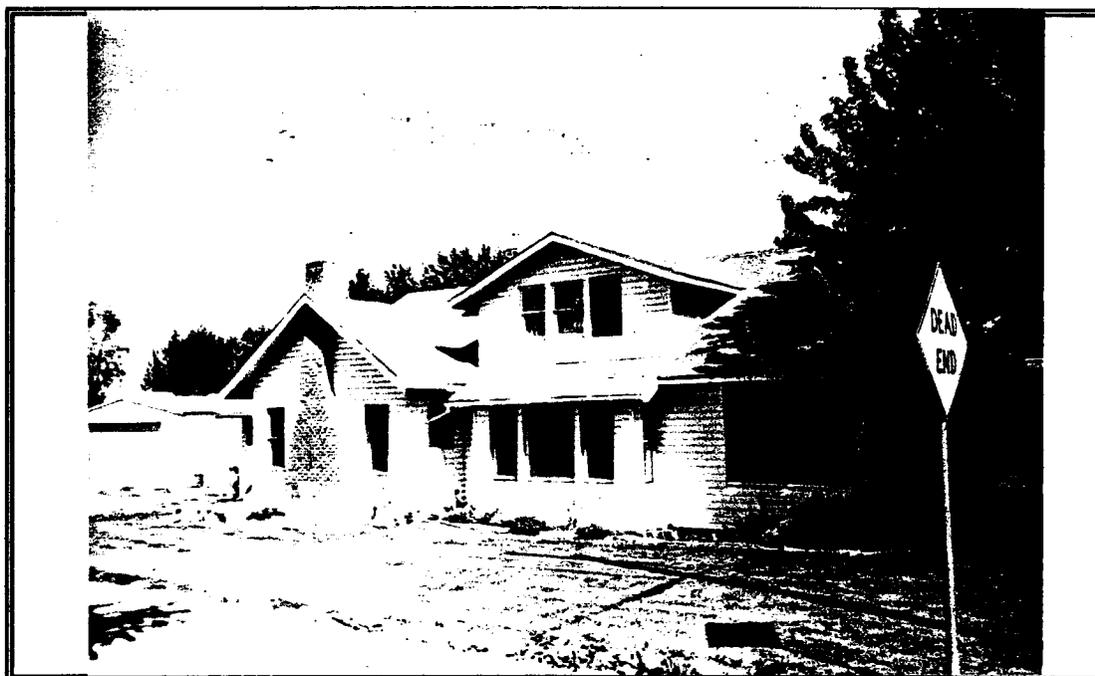
1. Inventory # 013
2. Historic and/or common name (if known) _____
3. Address of resource 3113 Mumbarto Avenue
4. Township Survey Data
NW 1/4 of NW 1/4 of NE 1/4 of Section 3 T3N R1E Boise-Meridian
5. Use/type classification Domestic
6. General Architectural description 1 1/2 story bungalow; gable roof with dormers. Metal siding, double hung windows. Brick chimney. Metal sided garage to the west.
7. Condition of Resource Good
8. National Register status (estimation) possibly eligible - district
9. Comments (including degree of development pressure and type on resource) No pressure. Zoned R8.

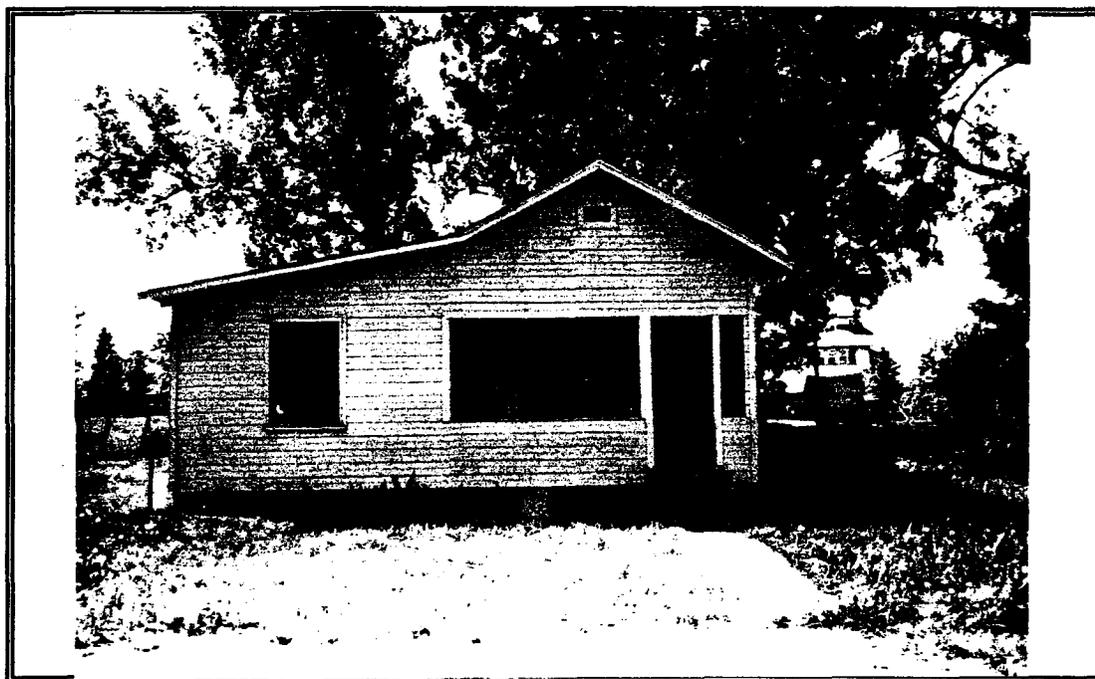
1. Inventory # 014
2. Historic and/or common name (if known) _____
3. Address of resource Southeast corner of Arch Street & Mumbarto Avenue
4. Township Survey Data
NW 1/4 of NW 1/4 of NE 1/4 of Section 3 T3N R1E Boise-Meridian
5. Use/type classification Domestic
6. General Architectural description 1 story wood frame. Rustic siding with corner boards. Gable roof with shed extension - exposed rafter ends. Recessed porch. 1/1 double hung windows.
7. Condition of Resource Excellent
8. National Register status (estimation) Possibly eligible - district
9. Comments (including degree of development pressure and type on resource) Vacant lot to the east; site would be threatened if this area were developed for residences. Road widening would impact this site. Zoned R8. Under pressure.

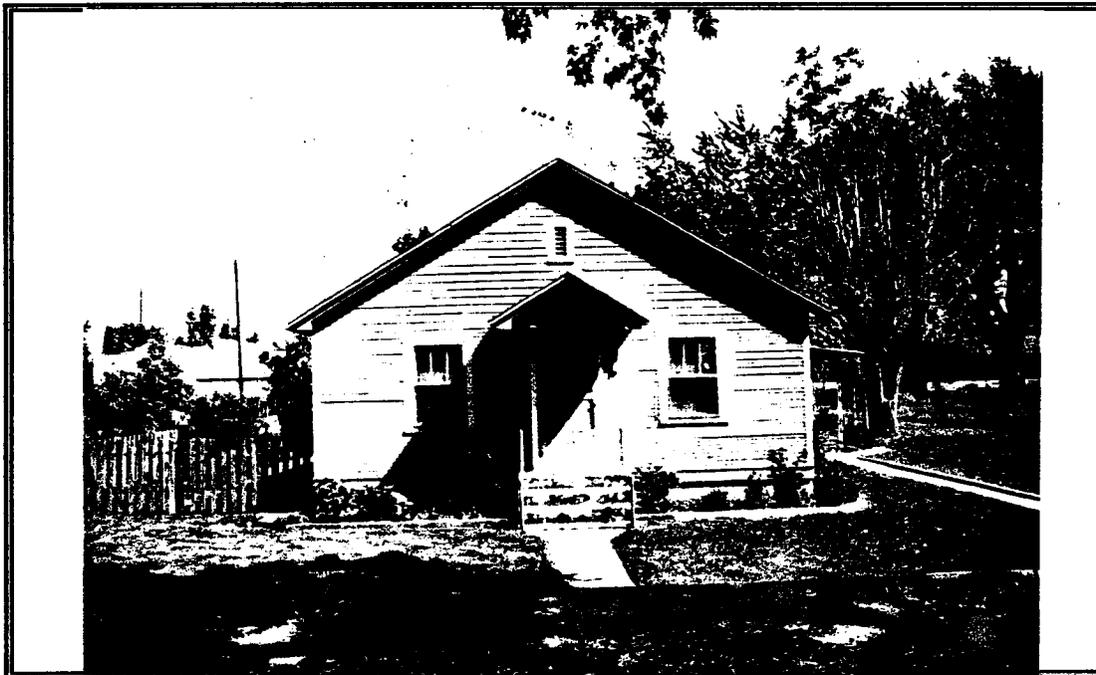
- 7. Condition of Resource Excellent
- 8. National Register status (estimation) possibly eligible - district
- 9. Comments (including degree of development pressure and type on resource) Zoned R8. No pressure

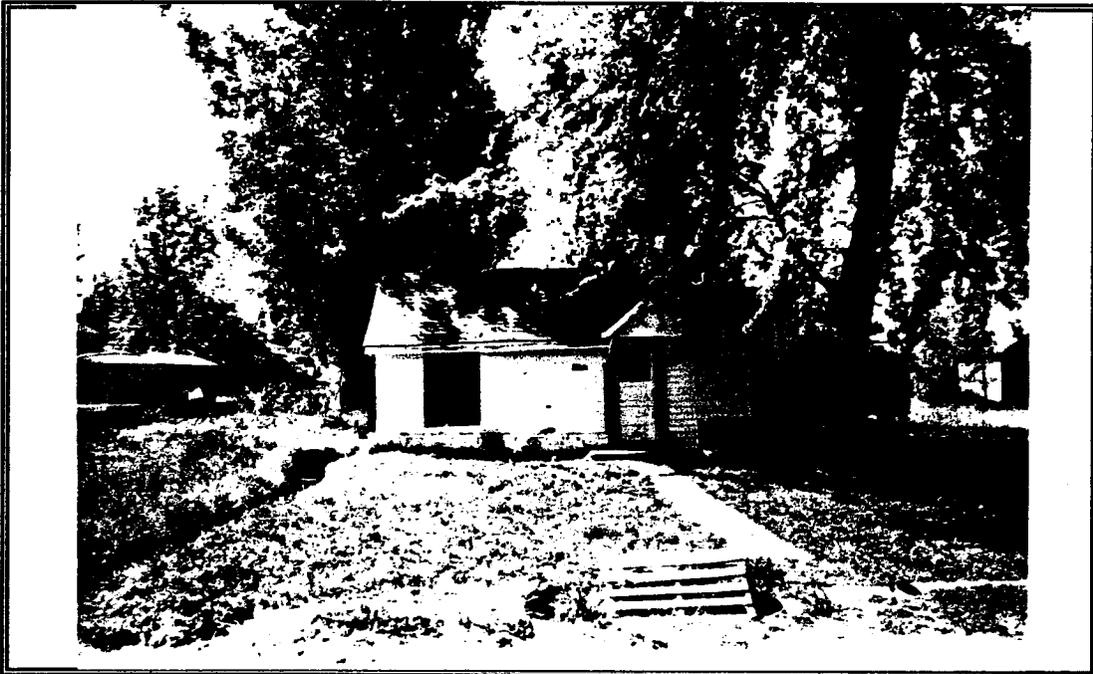
1. Inventory # 016
2. Historic and/or common name (if known) _____
3. Address of resource 11241 Race Street
4. Township Survey Data
NW 1/4 of NW 1/4 of NE 1/4 of Section 3 T3N R1E Boise-Meridian
5. Use/type classification Domestic
6. General Architectural description 1 story wood frame, gable roof, gable hood on brackets at entry. 4/4 double hung windows.
7. Condition of Resource fair
8. National Register status (estimation) possibly eligible - district
9. Comments (including degree of development pressure and type on resource) No pressure. Zoned R8.

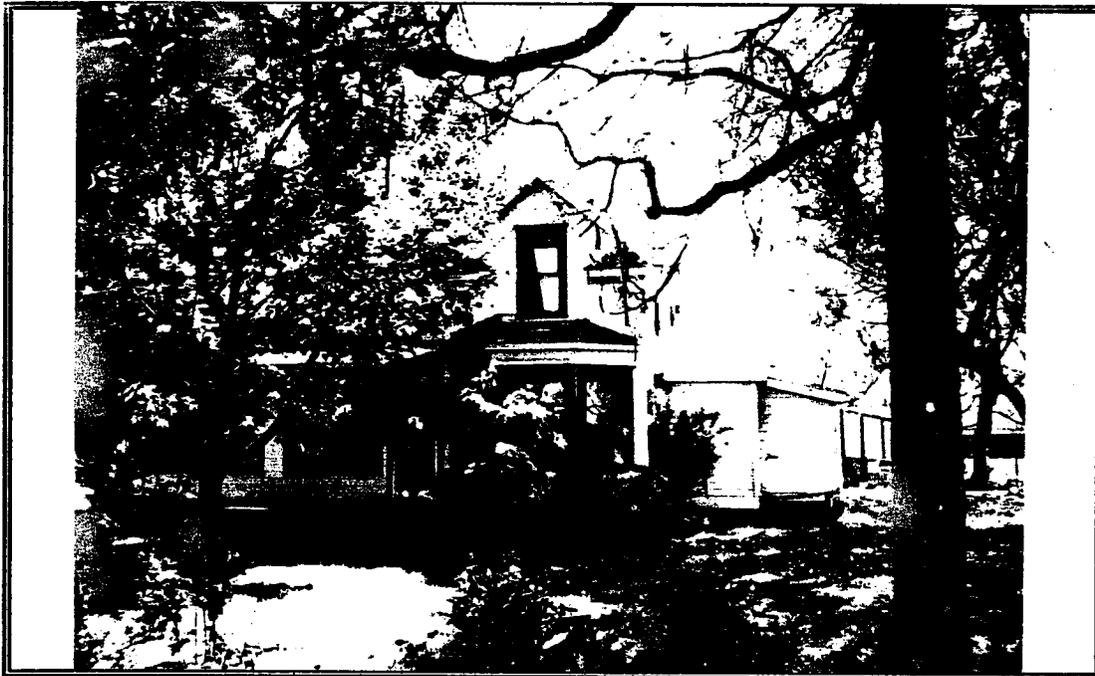
5. Use/type classification Domestic/Agricultural
6. General Architectural description 1 1/2 story wood frame, Greek Revival details, rustic siding. Gable intersecting roofs with eave returns. Bay windows at west. 1/1 double hung windows. Enclosed front porch. Deck added to front entry. One story addition to the south. Numerous wood frame outbuildings to the west.

7. Condition of Resource Excellent
8. National Register status (estimation) possibly eligible
9. Comments (including degree of development pressure and type on resource) Pasture to the east borders a trailer court. Pasture to east and south are vulnerable to development. Zoned AP-2 with R8 to the north and south and R11M to the east. Under pressure.

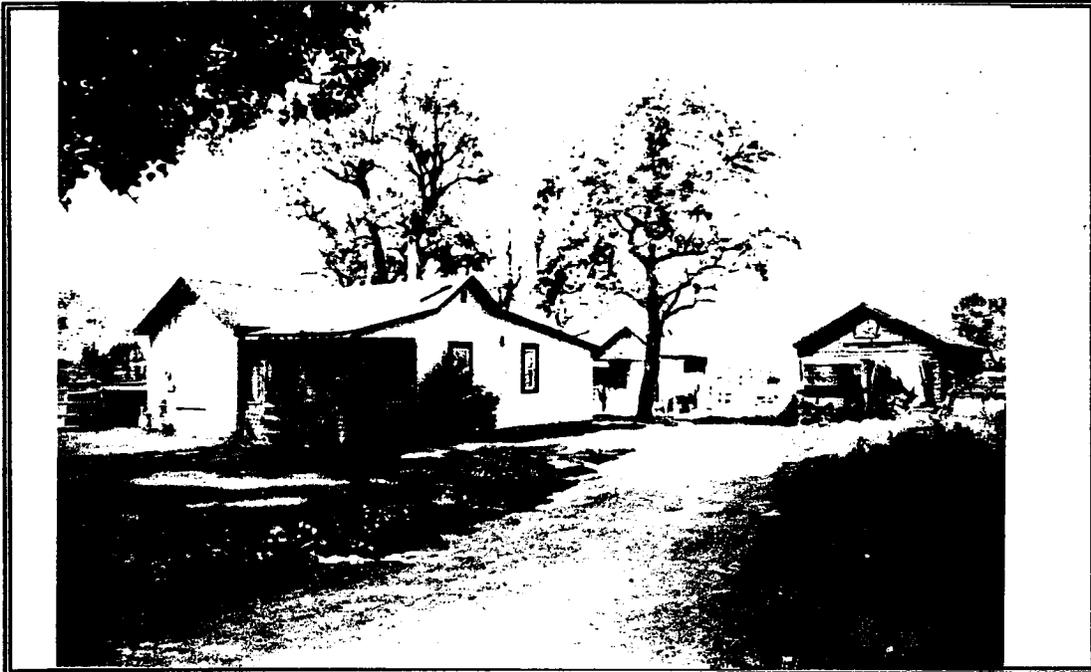
1. Inventory # 018
2. Historic and/or common name (if known) _____
3. Address of resource 2681 Wildwood Street
4. Township Survey Data
NW 1/4 of SW 1/4 of NE 1/4 of Section 3 T3N R1E Boise-Meridian
5. Use/type classification Domestic/Agricultural
6. General Architectural description 1 story wood frame. Rustic siding with cornerboards, intersecting gable roofs. 1/1 double hung windows. Enclosed front porch with decorative cut shingles. 4 wood frame outbuildings; 3 with gable roofs, 1 with shed roof.
7. Condition of Resource Fair
8. National Register status (estimation) unevaluated
9. Comments (including degree of development pressure and type on resource) Surrounded by pasture on south, west and north. Nursery/tree farm to far west. Pressure minimal, unless subdivided. Zoned AP-2 with R8 to the west and R1 to the south. Under pressure.

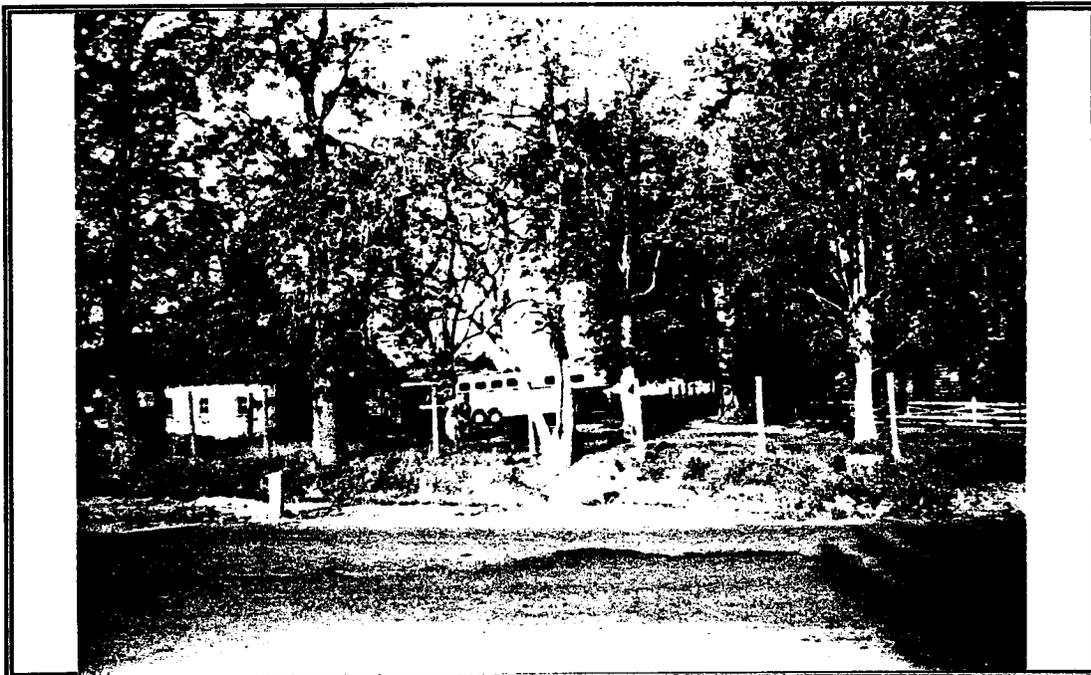
5. Use/type classification Residential/Agricultural
6. General Architectural description 1 1/2 story wood frame, pryamidal roof with gable extensions at front and rear. Original widows have been replaced with fixed and sliding windows. Wide horizontal siding is not original. Outbuildings include a barn and 2 sheds - all wood frame with gable roofs.

7. Condition of Resource Fair
8. National Register status (estimation) non-eligible
9. Comments (including degree of development pressure and type on resource) The site is surrounded by pasture on the south and west. Residential subdivisions are directly across the road to the east and northeast. Further residential development would impact this site. Zoned AP-2. Under pressure.

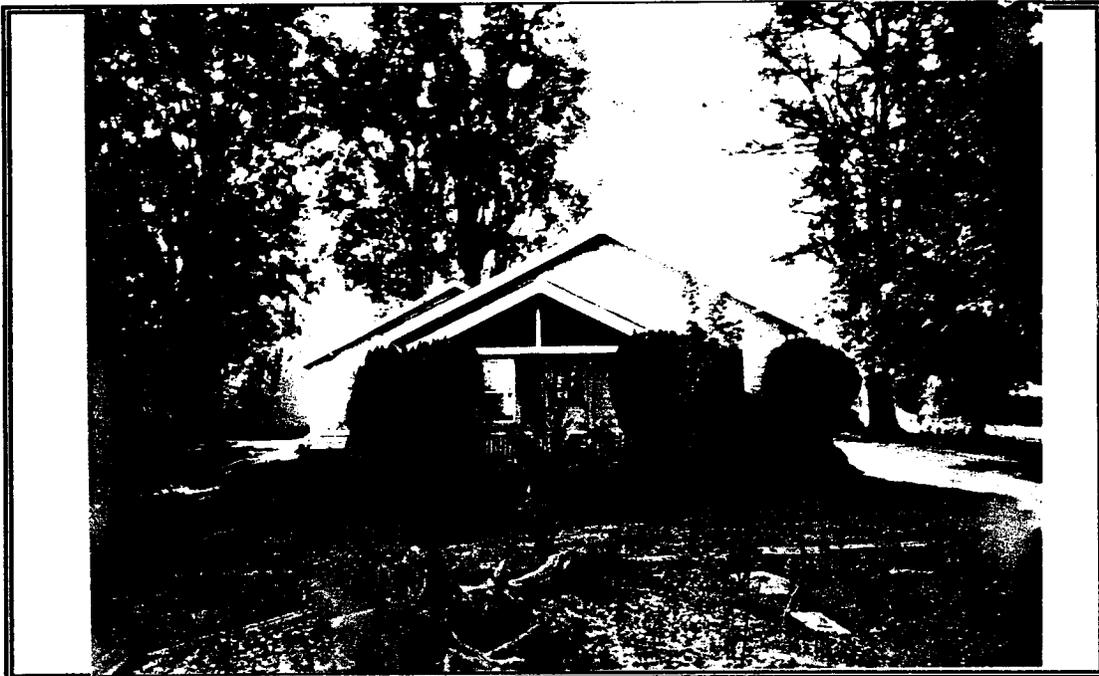
1. Inventory # 022
2. Historic and/or common name (if known) _____
3. Address of resource 1850 Wildwood Street
4. Township Survey Data
SE 1/4 of SW 1/4 of SE 1/4 of Section 3 T3N R1E Boise-Meridian
5. Use/type classification Residential/Agricultural
6. General Architectural description 1 1/2 story wood frame bungalow. Gable roof with open gable roofed porch, exposed rafter ends. Horizontal siding is metal. Outbuildings include a barn, garage and shed. All wood frame with gable roofs and metal roofing.
7. Condition of Resource Good
8. National Register status (estimation) unevaluated
9. Comments (including degree of development pressure and type on resource) The site is surrounded by pasture on the north and east. Residential subdevelopment has occurred about 1/4 mile to the north. The site would be impacted by residential development. Zoned R1. Under pressure.

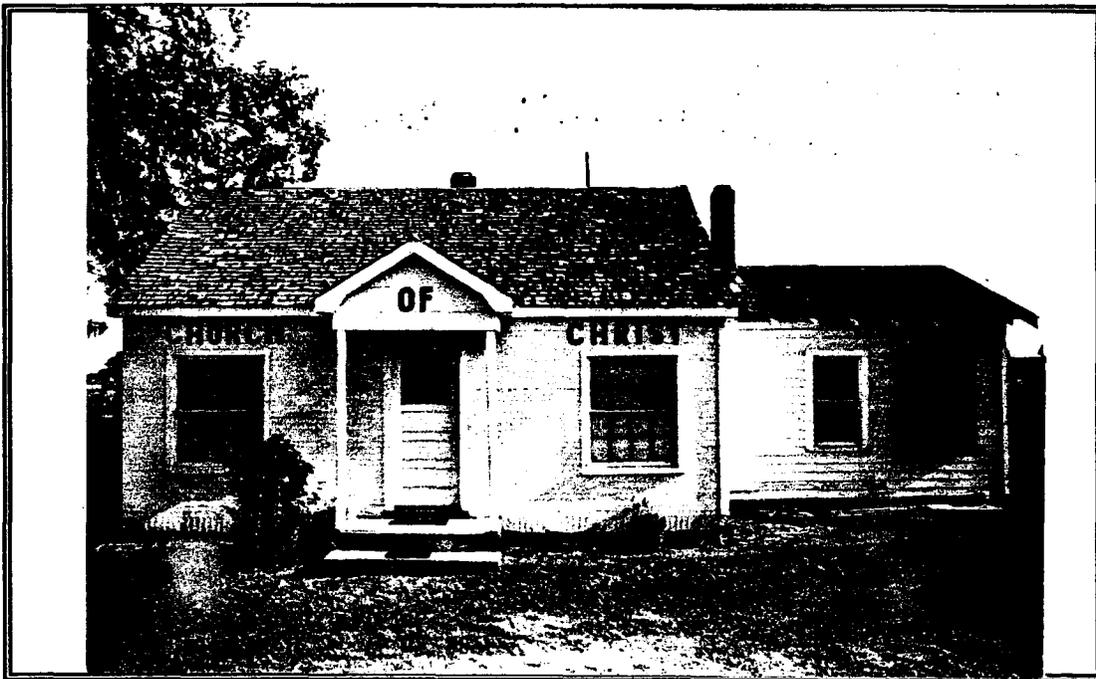
7. Condition of Resource Fair
8. National Register status (estimation) unevaluated
9. Comments (including degree of development pressure and type on resource) The site is impacted through road development at the intersection of Fairview and Five Mile. Commercial development has occurred to the immediate west. Residential subdivisions have occurred along Five Mile Road to the north. Also see Ada County Farmstead Survey 011833-011836. Under pressure with potential threat. Zoned R8

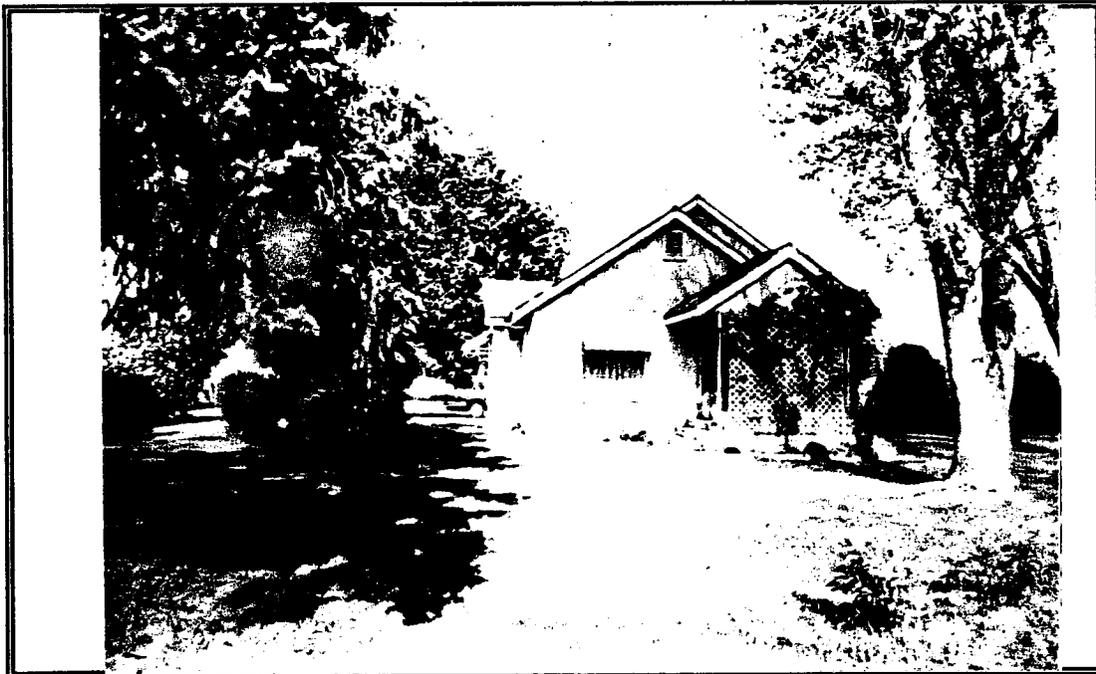
1. Inventory # 024
2. Historic and/or common name (if known) _____
3. Address of resource 2371 N. Five Mile Road
4. Township Survey Data
NE 1/4 of NE 1/4 of SE 1/4 of Section 3 T3N R1E Boise-Meridian
5. Use/type classification Domestic
6. General Architectural description 1 1/2 story wood frame, stucco finish with vertical siding in gable ends. Multiple pane fixed windows. Rear carport and shed addition.
7. Condition of Resource Good
8. National Register status (estimation) unevaluated
9. Comments (including degree of development pressure and type on resource) This site has been surrounded by residential developments and trailer courts. Zoned R8. Potential threat.

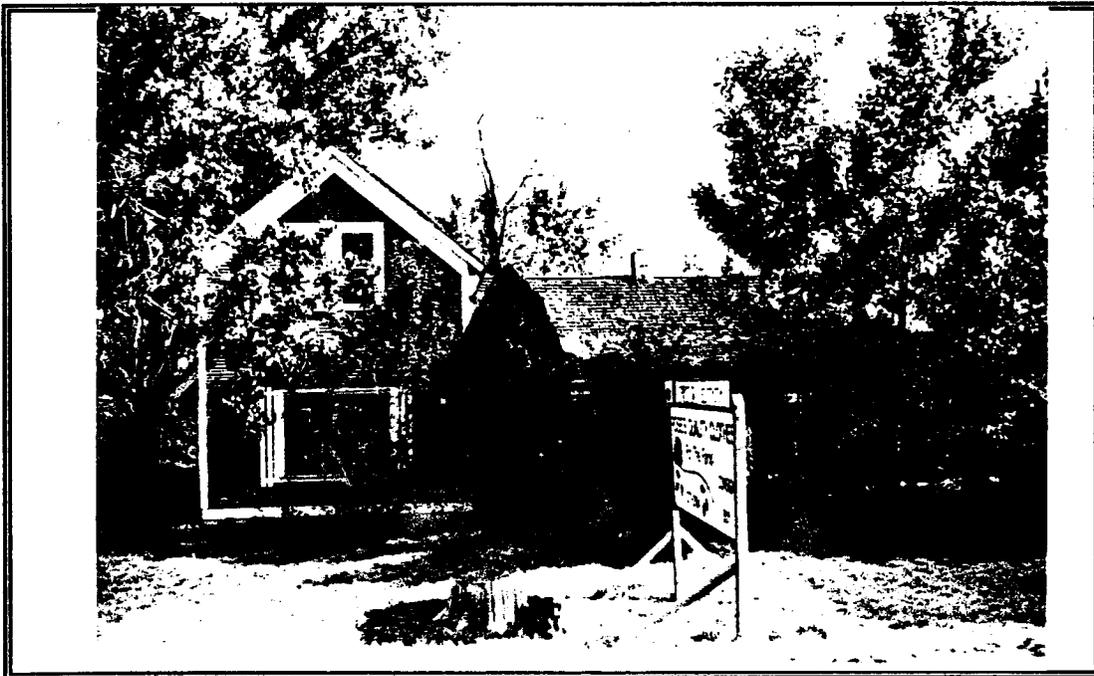
5. Use/type classification Commercial
6. General Architectural description 2 story wood frame with 1 1/2 story east wing. Rustic siding with cornerboards. 1 story flat roof addition to the east and north with T111 siding. Some original 1/1 double hung windows remain. Others are fixed multi-pane. Gable roofed wellhouse to the north.

7. Condition of Resource Fair
8. National Register status (estimation) unevaluated
9. Comments (including degree of development pressure and type on resource) The site is impacted by commercial development along Fairview. Some pasture remains on the west and north with residential development to the north. Its present commercial use may preserve the resource. Zoned C-2. Under pressure with potential threat.

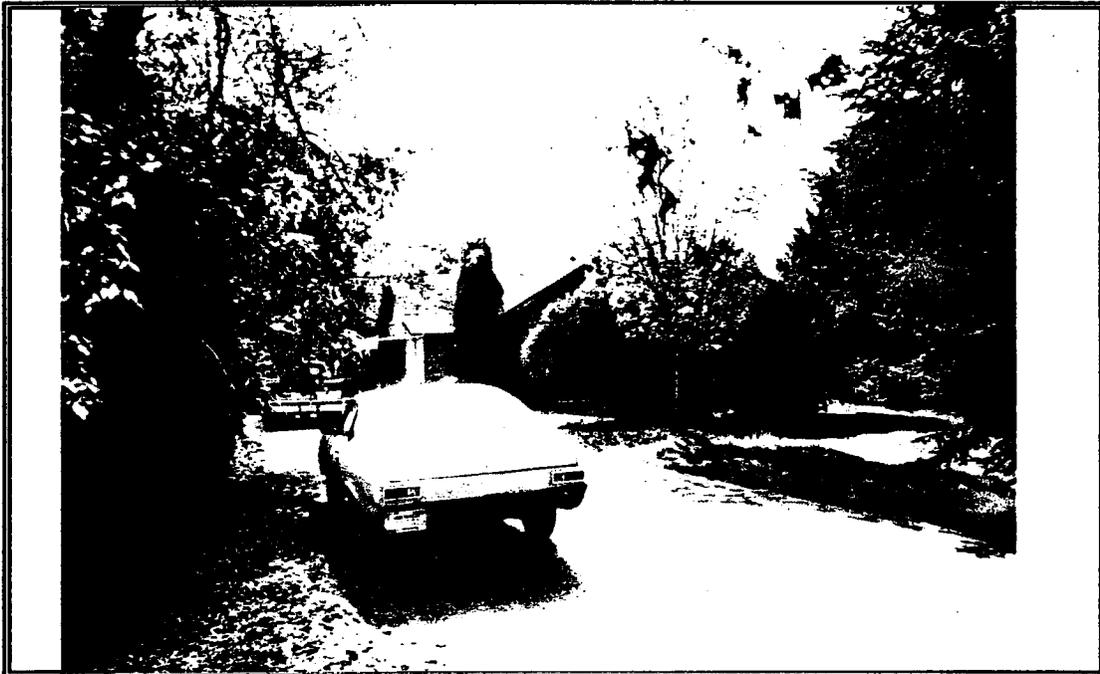
1. Inventory # 026
2. Historic and/or common name (if known) _____
3. Address of resource 2528 1/2 Cloverdale Road
4. Township Survey Data
SW 1/4 of SW 1/4 of NW 1/4 of Section 3 T3N R1E Boise-Meridian
5. Use/type classification Domestic
6. General Architectural description 1 1/2 story bungalow. Wood frame, narrow siding with shingles in gable ends. Decorative brackets - cross gable roofs. Stucco finish at southwest corner addition. 1 story garage and carport addition to the north.
7. Condition of Resource Good
8. National Register status (estimation) unevaluated
9. Comments (including degree of development pressure and type on resource) The site is surrounded by a tree farm which protects the resource from development, however it is zoned R8; Medium Density Residential Zone - Under pressure.

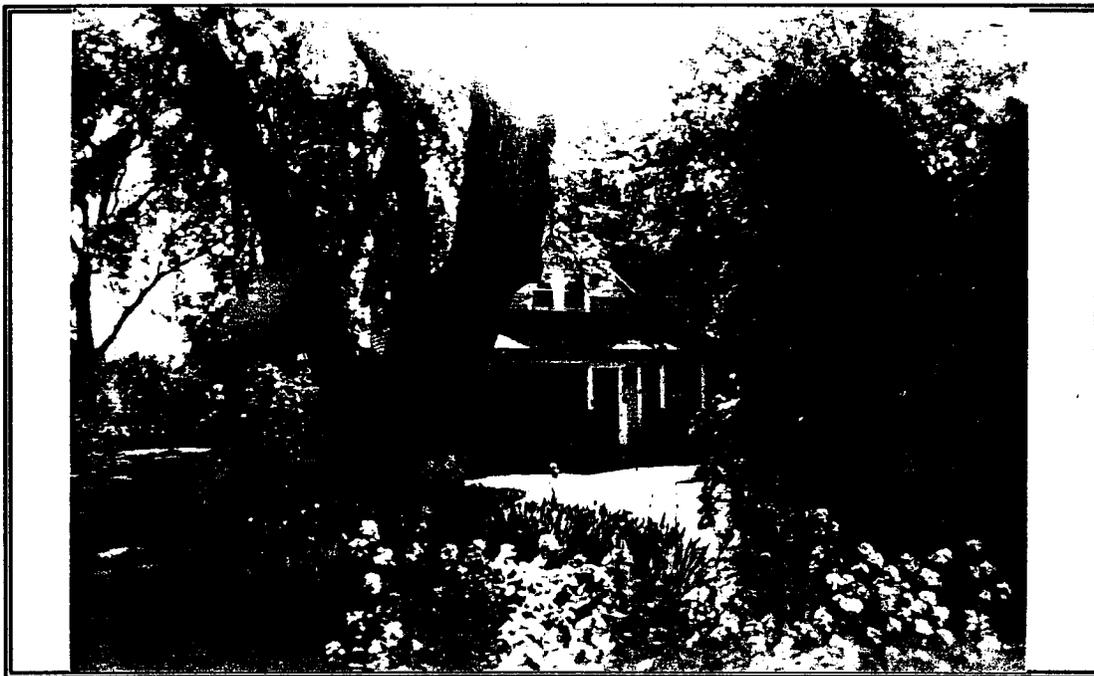
7. Condition of Resource Excellent
8. National Register status (estimation) Eligible
9. Comments (including degree of development pressure and type on resource) This site is surrounded by residential development. The only other impact would be the widening of Cloverdale Road. See Ada County Farmstead Survey 012444-50 for more information. Under pressure with potential threat. Zoned R1 for residence and R8 for agricultural buildings.
