BOISE CITY AREA OF CITY IMPACT
WINDSHIELD SURVEY OF HISTORIC RESOURCES

August 1992

By Donna Hartmans

For Ada County Historic Preservation Council
and
Boise City Historic Preservation Council

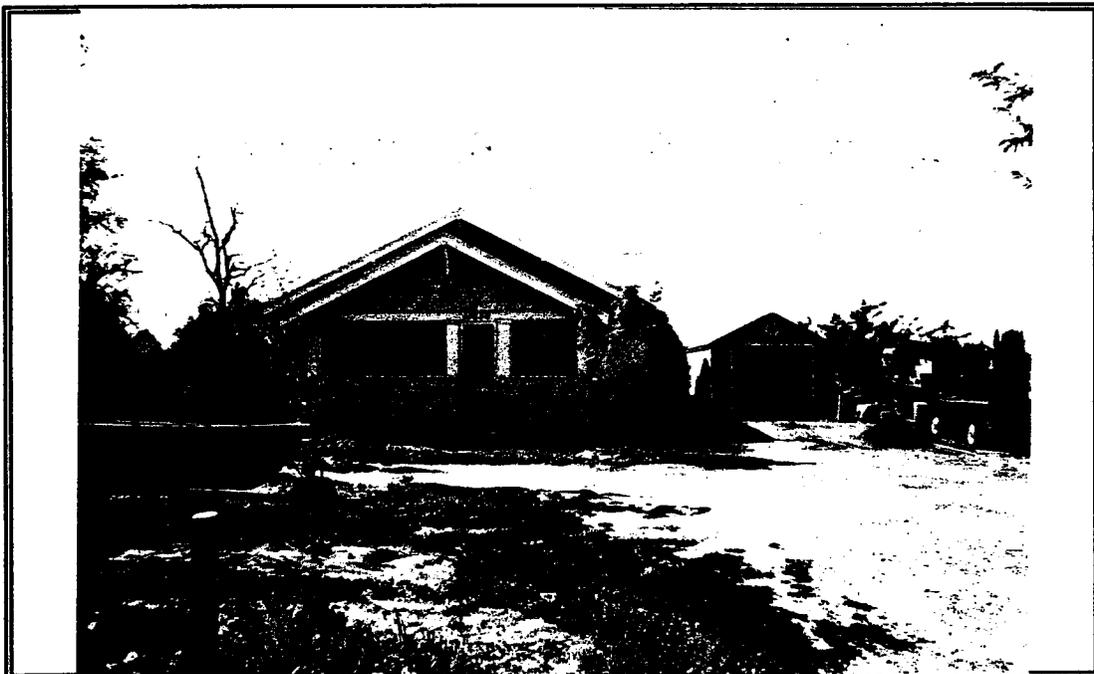
7. Condition of Resource Fair
8. National Register status (estimation) unevaluated
9. Comments (including degree of development pressure and type on resource) This site is surrounded by pasture with residential development to the south and west. Abandoned property with two outbuildings to the immediate east and a church beyond. Widening of McMillan Road would impact this site as would additional residential development. Zoned R1. Under pressure with potential threat.

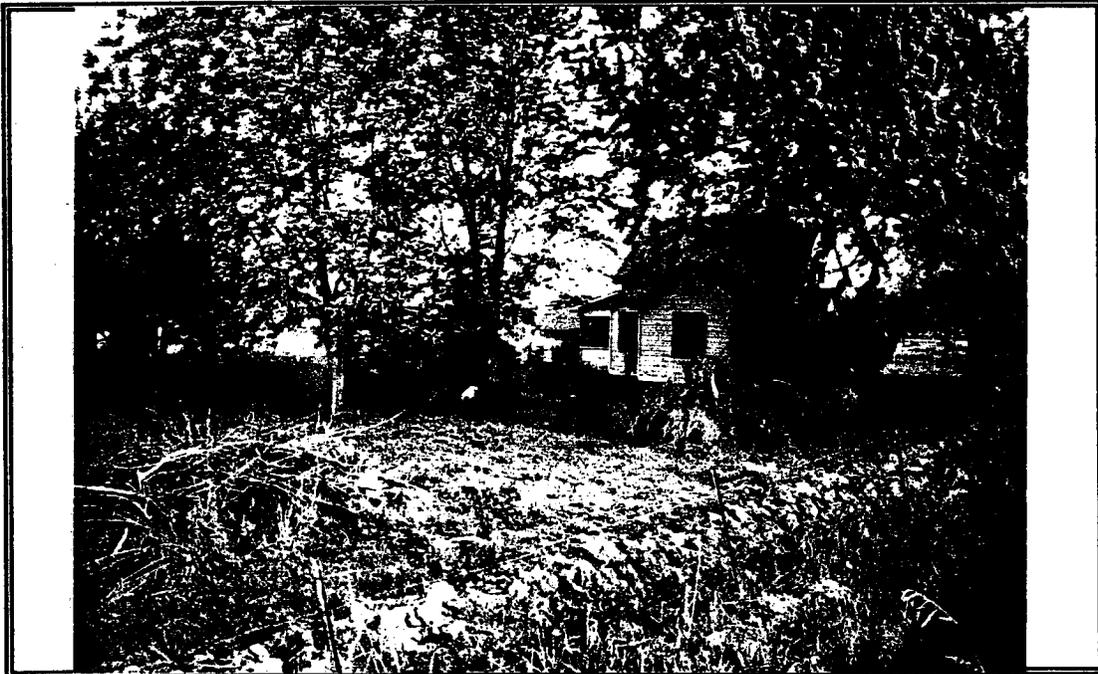
5. Use/type classification Domestic/Agricultural
6. General Architectural description 1 1/2 story wood frame with gable roof with eave returns and one story gable wing to the south. Rustic siding. Gable hood over entry. Windows are boarded over. One story wood frame addition to the rear. Also cast concrete block/brick rear addition. Outbuildings: 1 story concrete block garage with gable roof, 4-5 wood frame sheds to the south and southwest of the residence.

7. Condition of Resource Deteriorated - abandoned
8. National Register status (estimation) not eligible
9. Comments (including degree of development pressure and type on resource) This site is surrounded by pasture on the south, north, and west. Residential development has occurred to the east across Gary Lane. Further residential development or commercial development will impact this site. Under pressure with potential threat. Zoned R1.

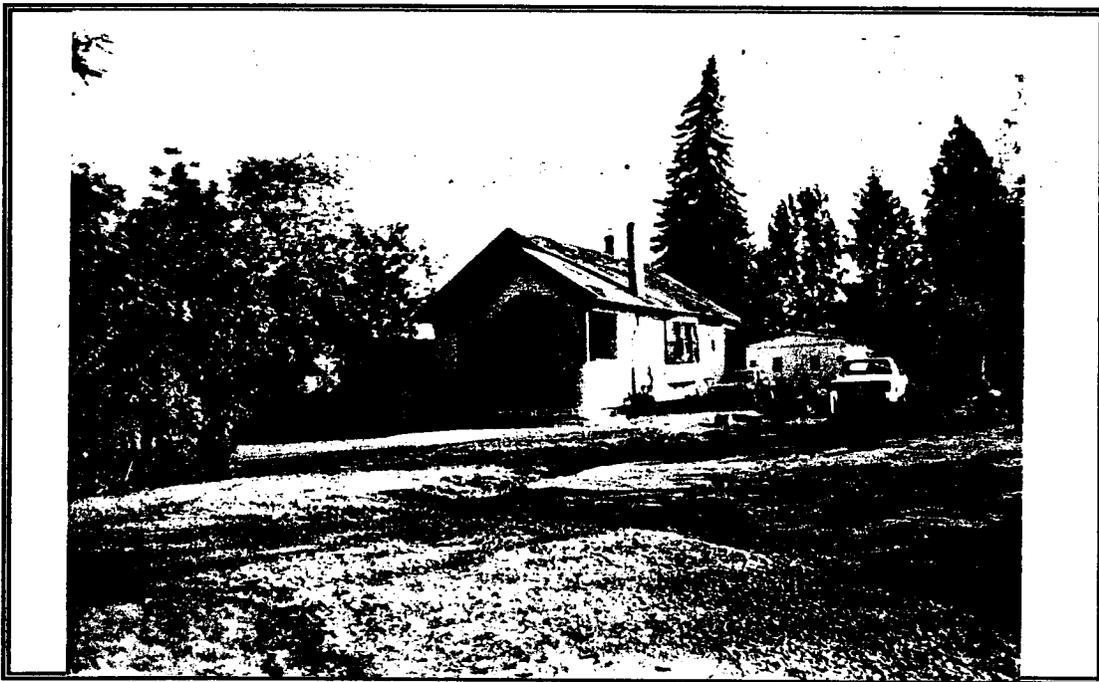
1. Inventory # 030
2. Historic and/or common name (if known) _____
3. Address of resource 7456 West State Street
4. Township Survey Data
NE 1/4 of NW 1/4 of SE 1/4 of Section 24 T4N R1E Boise-Meridian
5. Use/type classification Domestic
6. General Architectural description 1 1/2 story bungalow. Gable roof with projecting open gable porch. Exposed rafter ends, decorative brackets. Bay window on east side. Narrow lap siding. 1/1 double hung windows. Chimney at east. Gable roofed garage.
7. Condition of Resource Good
8. National Register status (estimation) unevaluated
9. Comments (including degree of development pressure and type on resource) Pasture land to the north presently. If developed for residential lots - would impact this site. Zoned R1. Under pressure.

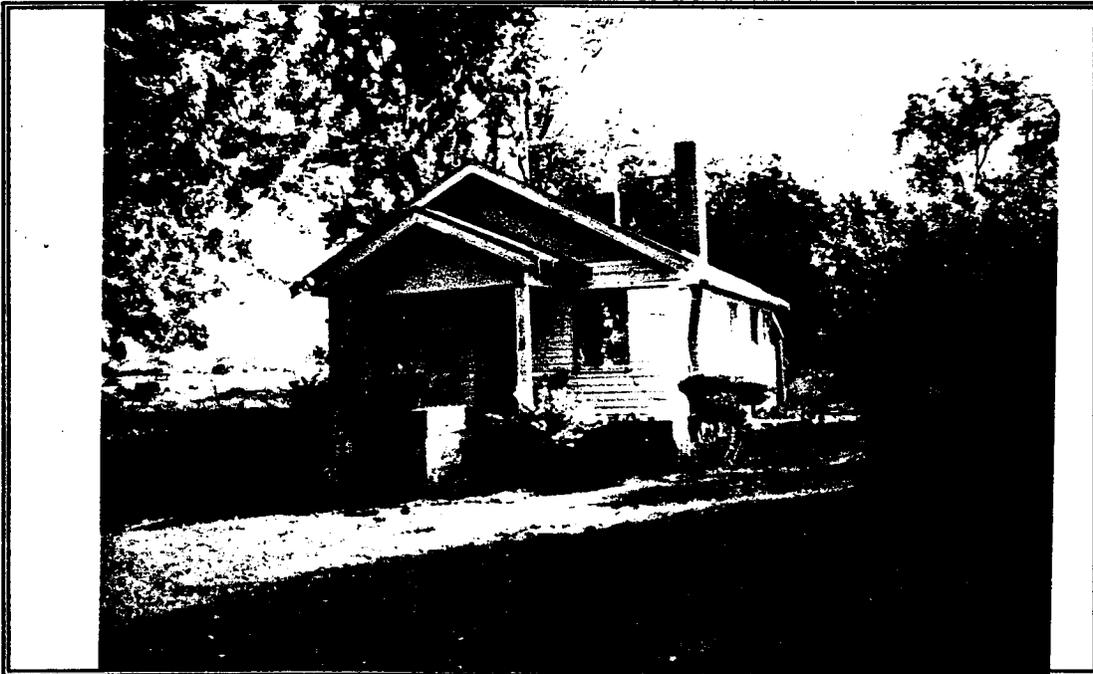
1. Inventory # 031
2. Historic and/or common name (if known) _____
3. Address of resource 7501 West State Street
4. Township Survey Data
NE 1/4 of NW 1/4 of SE 1/4 of Section 24 T4N R1E Boise-Meridian
5. Use/type classification Domestic
6. General Architectural description 1 1/2 story wood frame bungalow. Gable roof. Projecting open gable roofed porch. Many of the windows and siding has been altered. Chimney on east side. Outbuilding include wood frame garage with gable roof and wide board siding. A garage with narrow lap siding and gable roof. Two sheds and a well house.
7. Condition of Resource Fair
8. National Register status (estimation) not eligible
9. Comments (including degree of development pressure and type on resource) Presently pasture land to the north which could be used for residential development - this would impact the site. Under pressure. Zoned R1.

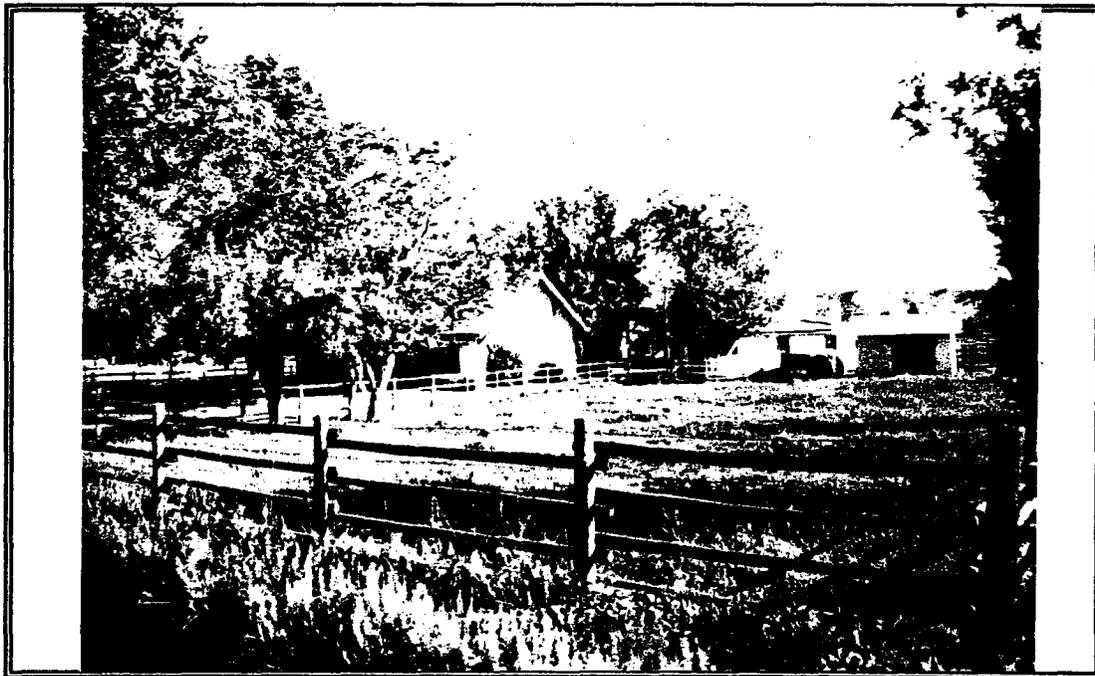
7. Condition of Resource Excellent
8. National Register status (estimation) unevaluated
9. Comments (including degree of development pressure and type on resource) This property is surrounded by agricultural land. Residential development of this area would impact this site. Under pressure. Zoned AP-2.
See Ada County Farmstead Survey 012575-84

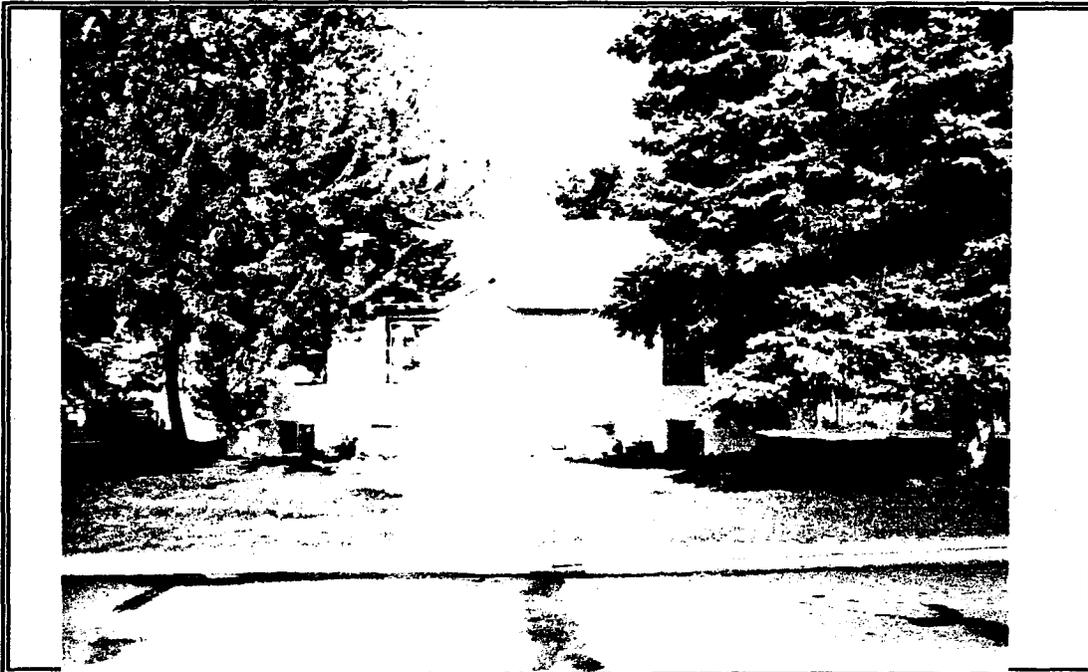
7. Condition of Resource Good
8. National Register status (estimation) unevaluated
9. Comments (including degree of development pressure and type on resource) This property is surrounded by agricultural land on the south, north and west. Road widening would impact this site. Residential development is occurring to south and southwest currently. Under pressure with potential threat. Also see Ada County Farmstead Survey 012548-63. This property was rezoned R-1C within the Boise City limits during the course of this project.

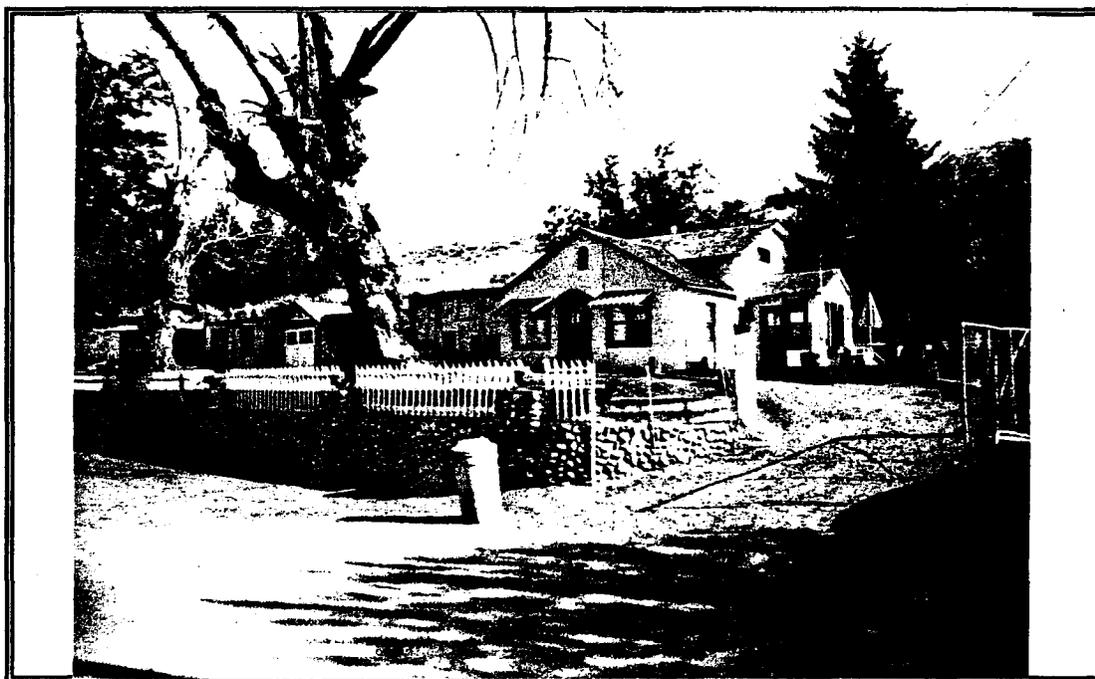
7. Condition of Resource Good
8. National Register status (estimation) unevaluated
9. Comments (including degree of development pressure and type on resource) This property is located against a hill. Any residential development in the foothills or road widening would impact this site. Zoned AP-2. Under pressure with potential threat.

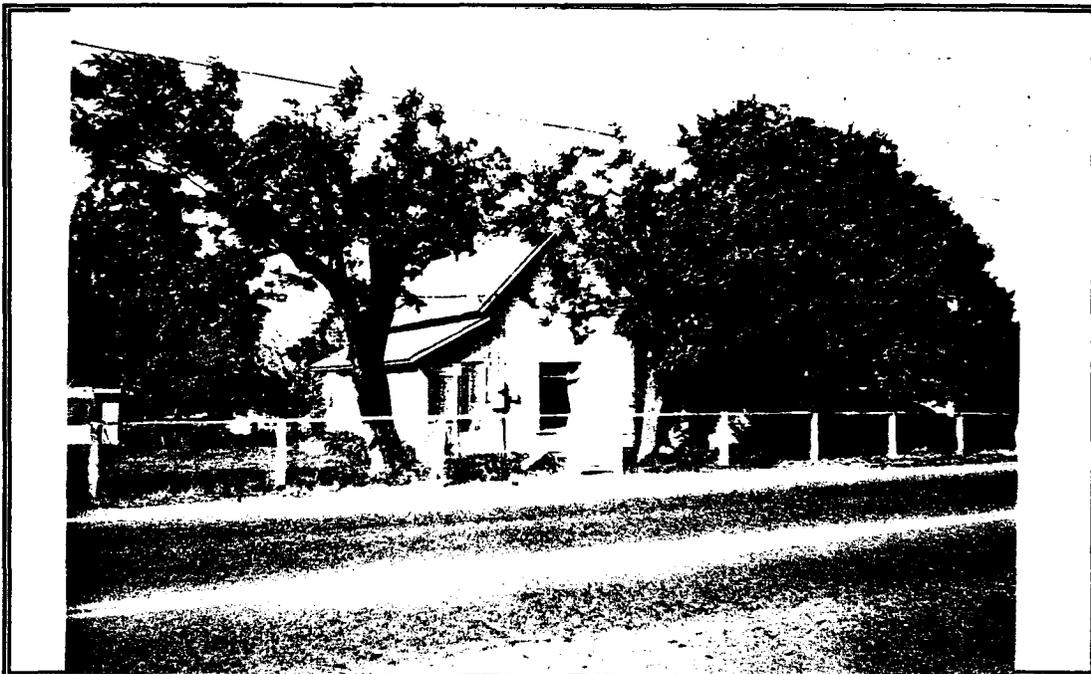
1. Inventory # 036
2. Historic and/or common name (if known) _____
3. Address of resource 7107 Hill Road
4. Township Survey Data
NW 1/4 of NE 1/4 of SE 1/4 of Section 13 T4N R1E Boise-Meridian
5. Use/type classification Domestic
6. General Architectural description 1 1/2 story wood frame, gable roof with intersecting cross gable. Enclosed porch with shed roof extension to the east. Narrow and wide rustic siding. A bay window to the north. Variety of windows 4/4, 6/1, double hung and fixed. A few small sheds to the south of the house.
7. Condition of Resource Good
8. National Register status (estimation) unevaluated
9. Comments (including degree of development pressure and type on resource) This resource will be greatly impacted if the road is widened. Under pressure with potential threat. Zoned R8.

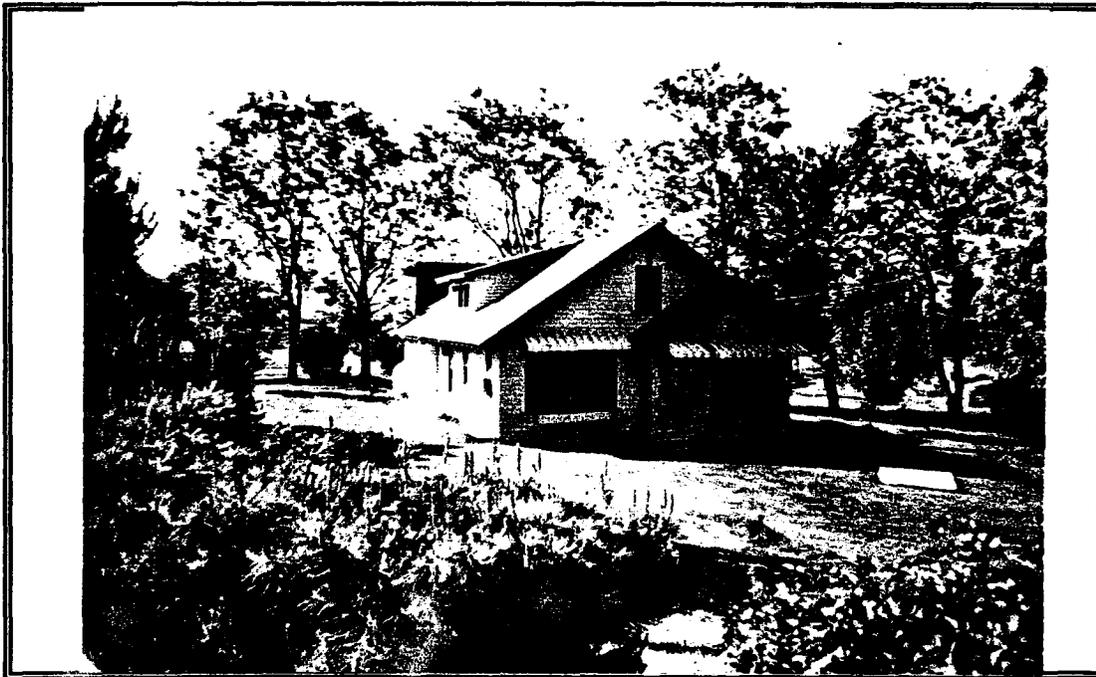
1. Inventory # 037
2. Historic and/or common name (if known) _____
3. Address of resource 7820 Gary Lane (SE corner of Hill Road & Gary Lane)
4. Township Survey Data
NW 1/4 of NE 1/4 of SE 1/4 of Section 13 T4N R1E Boise-Meridian
5. Use/type classification Domestic
6. General Architectural description 1 1/2 story wood frame bungalow with gable roof, shed dormers, exposed rafter ends, decorative brackets. Horizontal lap siding. Open 2nd story porch addition to the rear. A small shed and carport/shop are located to the south.
7. Condition of Resource Good
8. National Register status (estimation) unevaluated
9. Comments (including degree of development pressure and type on resource) Widening Hill Road and Gary Lane could impact this property. Zoned R8. Under pressure with potential threat.

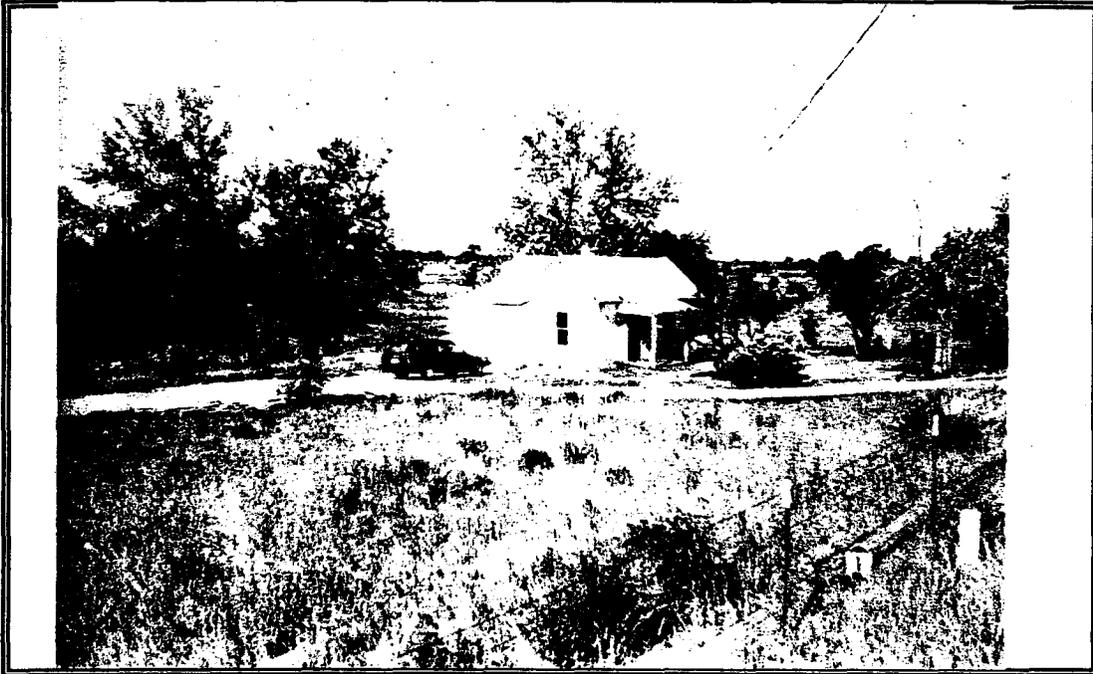
1. Inventory # 038
2. Historic and/or common name (if known) _____
3. Address of resource 7433 Hill Road
4. Township Survey Data
SE 1/4 of SW 1/4 of NE 1/4 of Section 13 T4N R1E Boise-Meridian
5. Use/type classification Domestic
6. General Architectural description 1 story wood frame, intersecting gable roofs. Open shed roofed front porch. 1/1 double hung windows. Rustic lap siding. A board and batten shed, shed roofed outbuilding is located to the east of the house.
7. Condition of Resource Good
8. National Register status (estimation) unevaluated
9. Comments (including degree of development pressure and type on resource) This property is surrounded by pasture. A subdivision is being currently developed to the south. Further residential development will impact this site. Under pressure with potential threat. Zoned R1 with AP-2 surrounding.

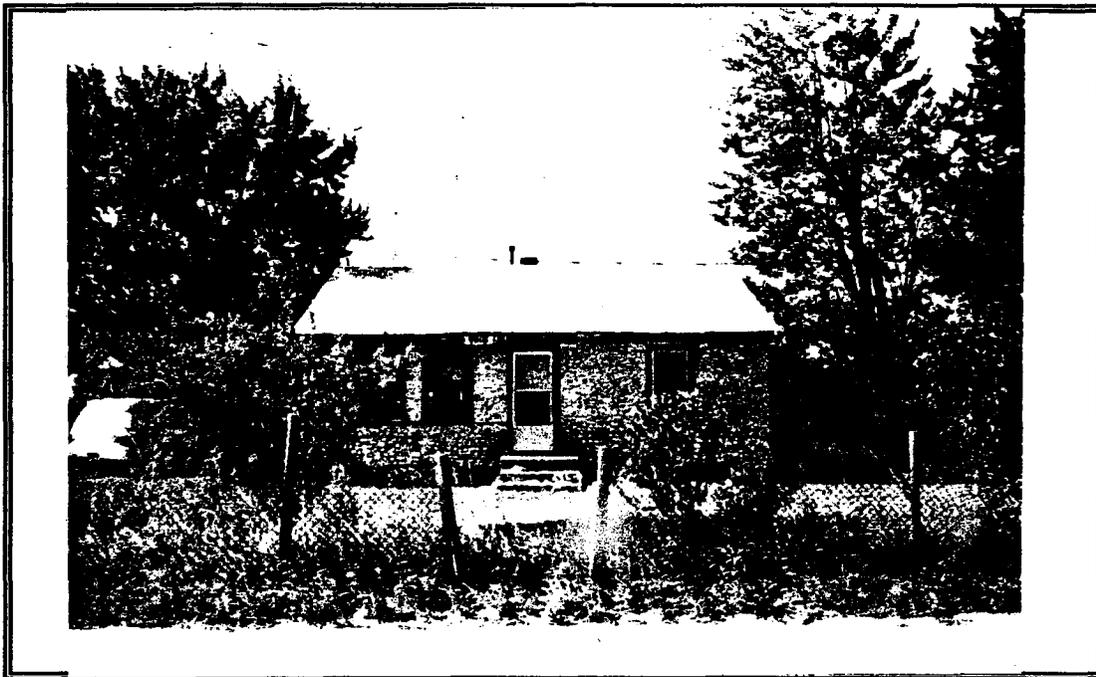
1. Inventory # 039
2. Historic and/or common name (if known) _____
3. Address of resource 7613 Hill Road
4. Township Survey Data
SE 1/4 of SE 1/4 of NW 1/4 of Section 13 T4N R1E Boise-Meridian
5. Use/type classification Domestic
6. General Architectural description 1 1/2 story wood frame. The stucco finish has fieldstone embedded in it. The main gable roof has a shed roof extension to the rear with vertical board siding.
7. Condition of Resource Fair
8. National Register status (estimation) unevaluated
9. Comments (including degree of development pressure and type on resource) This site is surrounded by farmland. Any residential development will impact this site. Zoned AP-2 with R1 to the east and west. Under pressure with potential threat.

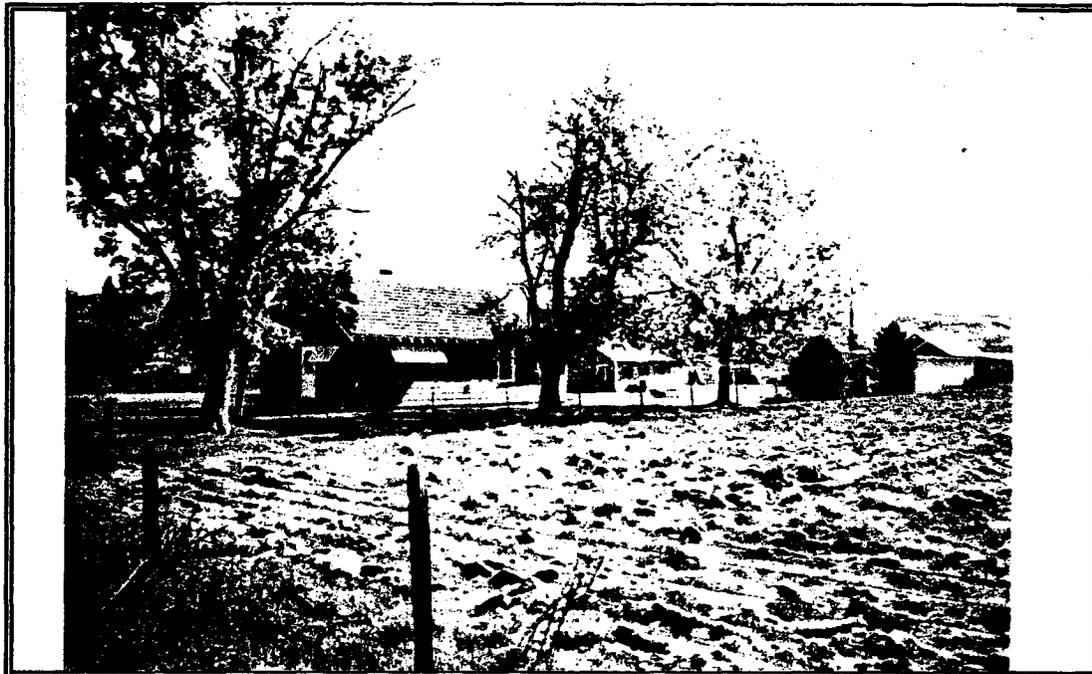
7. Condition of Resource Good
8. National Register status (estimation) unevaluated
9. Comments (including degree of development pressure and type on resource) This resource is surrounded by pasture land. Potential school development to the east off of Sloan Drive. Zoned R1 with AP-2 surrounding. Under pressure with potential threat. Also see Ada County Farmstead Survey 012521-30

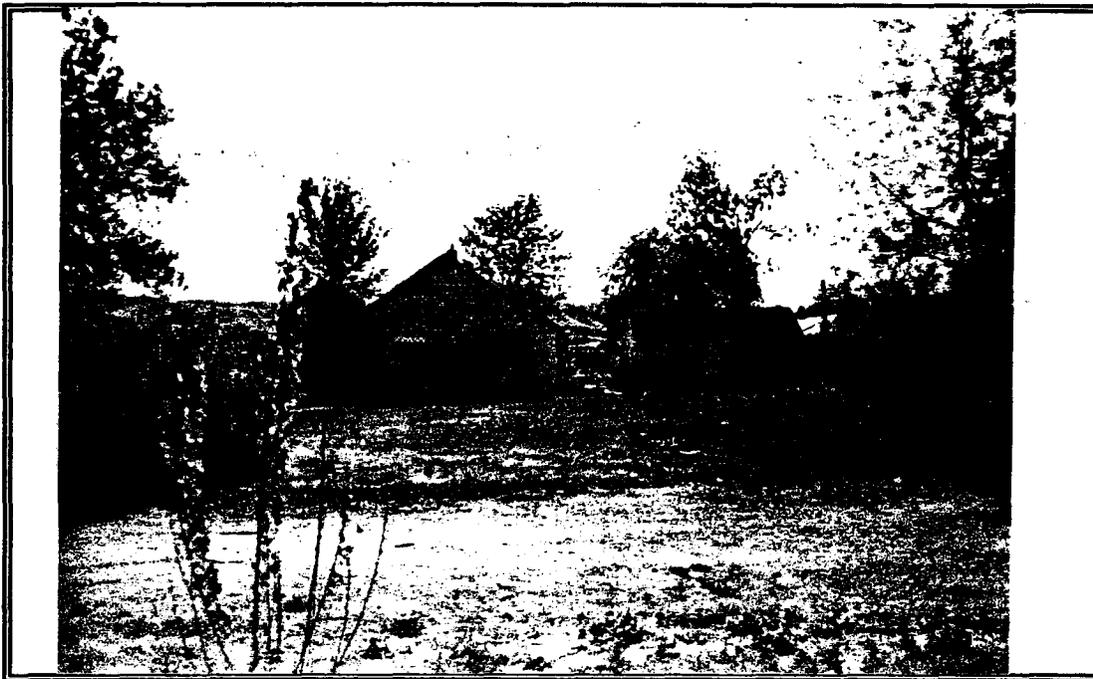
7. Condition of Resource Fair
8. National Register status (estimation) not eligible
9. Comments (including degree of development pressure and type on resource) This resource is surrounded by pasture land. Residential subdivision development will impact this site. Zoned AP-2. Under pressure with potential threat. Also see Ada County Farmstead Survey 012531-40

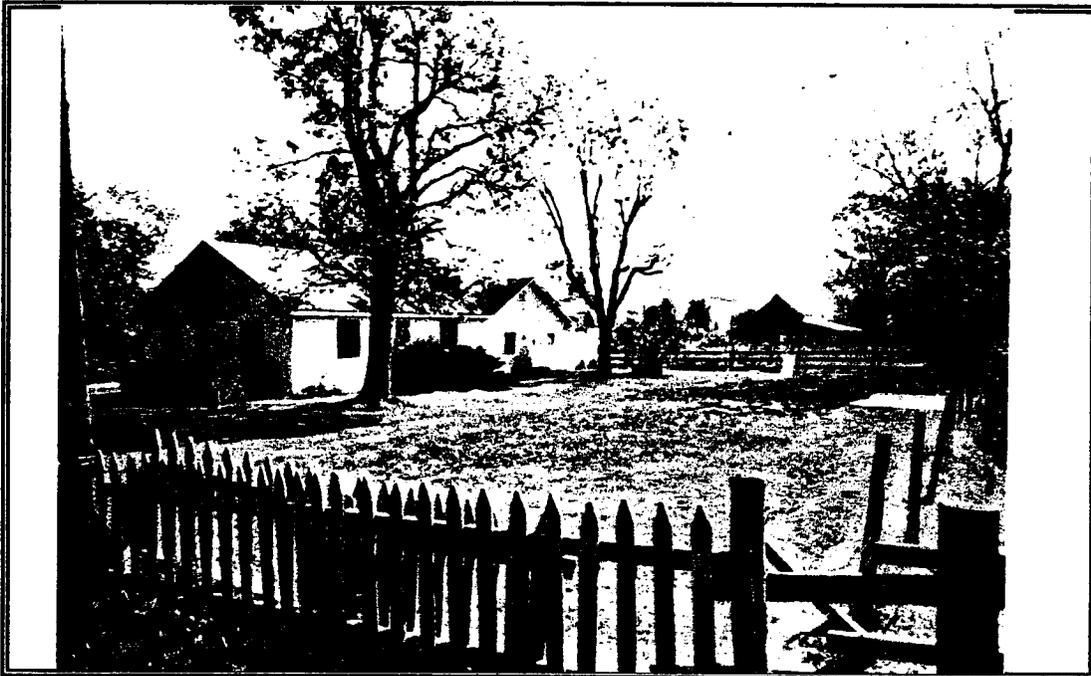
7. Condition of Resource Good
8. National Register status (estimation) unevaluated
9. Comments (including degree of development pressure and type on resource) The resource is surrounded by pasture land. Residential development will impact this site. Zoned AP-2 with R1 to the east. Under pressure with potential threat. Also see Ada County Farmstead Survey 012541 and Ada County Reconnaissance Survey 174.

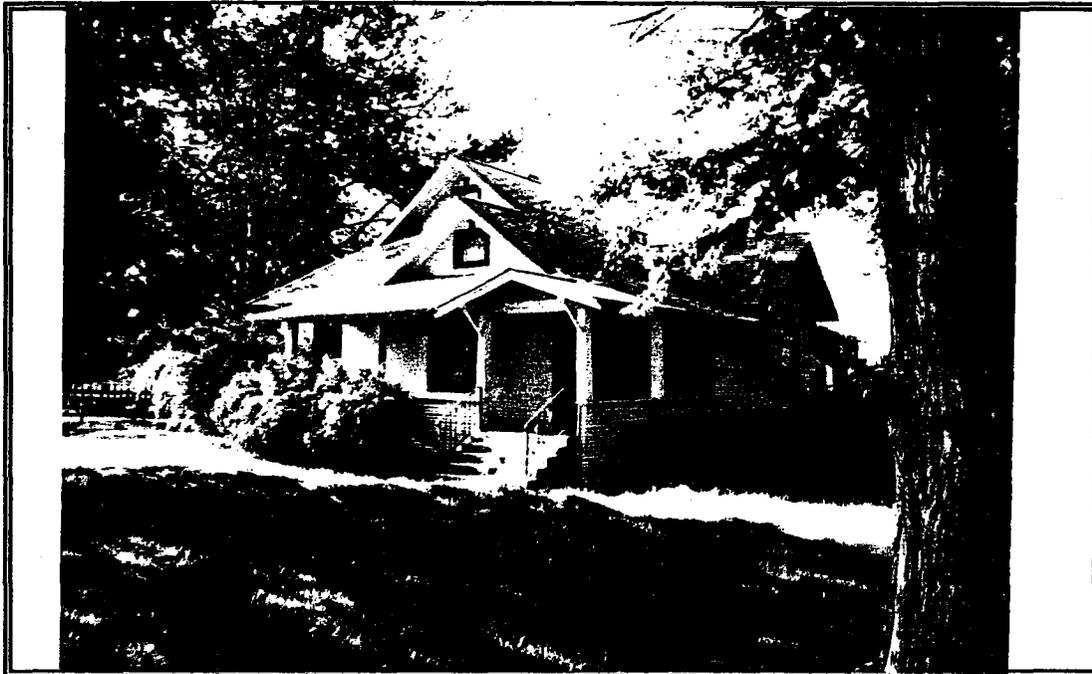
7. Condition of Resource Excellent
8. National Register status (estimation) eligible
9. Comments (including degree of development pressure and type on resource) The resource would be impacted if widening of Bogart Lane occurred. Zoned R1 with C-2 to the east. Under pressure with potential threat.

Also see Ada County Farmstead Survey 012585-87

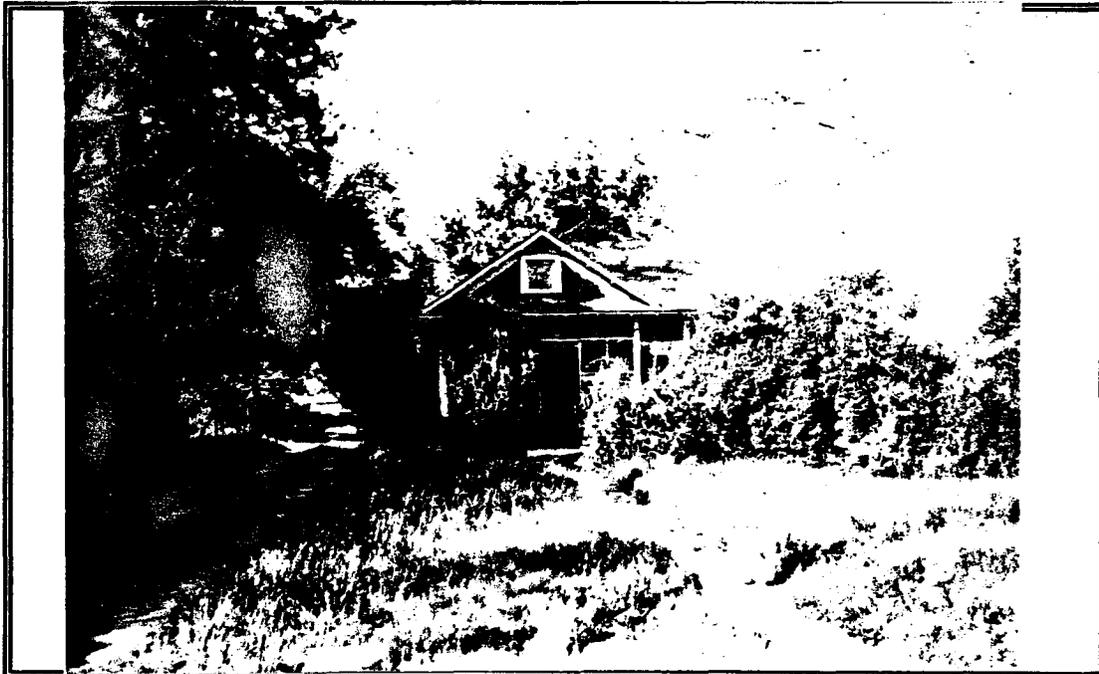
7. Condition of Resource Fair-abandoned?
8. National Register status (estimation) unevaluated
9. Comments (including degree of development pressure and type on resource) The property appears to be abandoned. It is surrounded by fields. A mobile home park is to the west and residential development is occurring to the south. Further residential development will impact this site. Under pressure. Zoned R1.

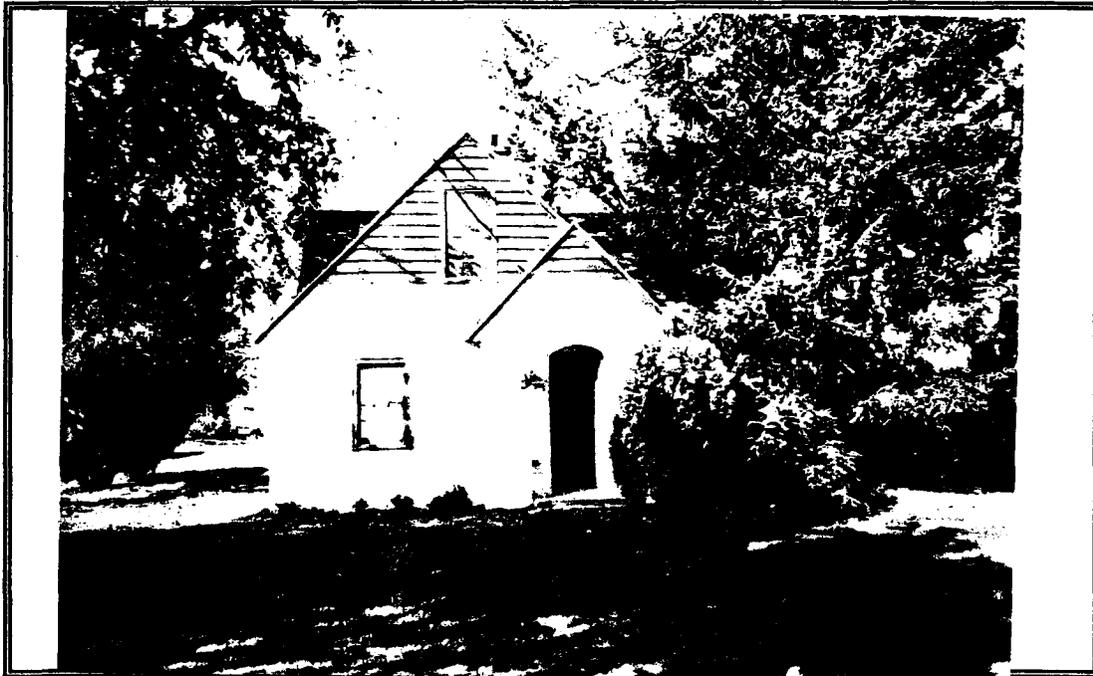
1. Inventory # 045
2. Historic and/or common name (if known) _____
3. Address of resource 7601 W. State Street
4. Township Survey Data
SW 1/4 of SW 1/4 of NE 1/4 of Section 24 T4N R1E Boise-Meridian
5. Use/type classification Domestic
6. General Architectural description 1 1/2 story, wood frame, cross gable roof. Stucco finish with wide horizontal siding in the gable ends. 6/6 and 4/1 double hung windows. Arched front entry with smooth finish surrounds. Gable roofed 2 car garage to the rear.
7. Condition of Resource Good
8. National Register status (estimation) unevaluated
9. Comments (including degree of development pressure and type on resource) This property is surrounded by agricultural land on the west and south. It would be impacted with residential development of these areas. Under pressure. Zoned R1.

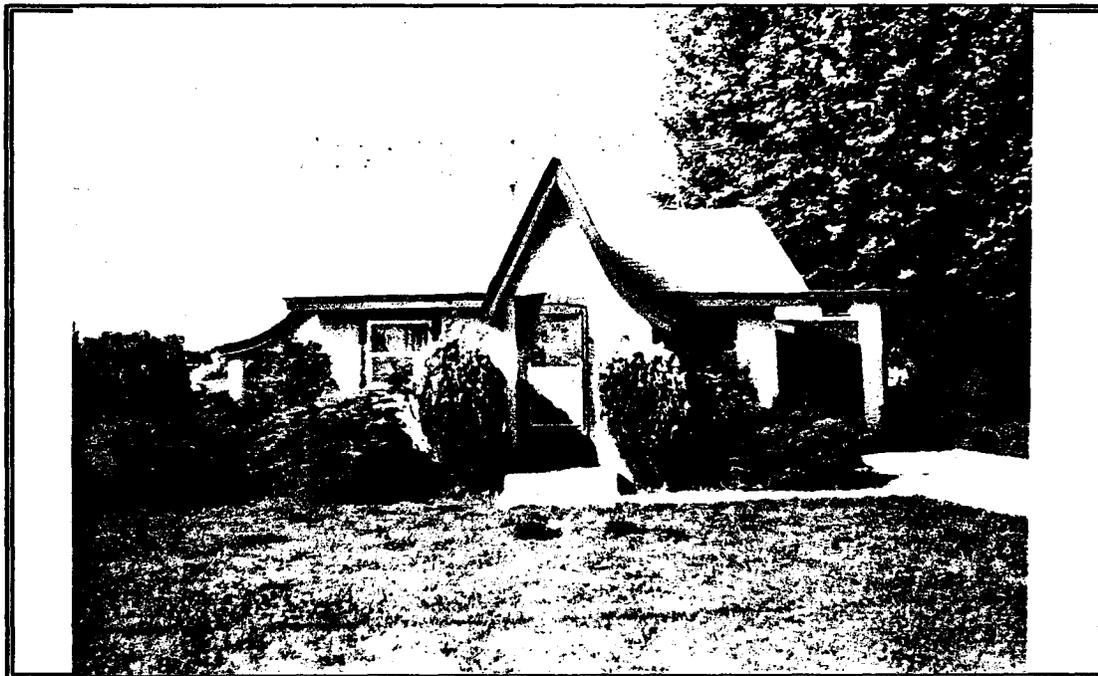
1. Inventory # 046
2. Historic and/or common name (if known) _____
3. Address of resource 7575 W. State Street
4. Township Survey Data
SW 1/4 of SW 1/4 of NE 1/4 of Section 24 T4N R1E Boise-Meridian
5. Use/type classification Domestic
6. General Architectural description 1 story English Cottage with cross gable roof. Steep gable roofed, projecting entry. Stucco finish to the west. Wall extension to the east provides archway to side yard. A gable roofed shed with narrow lap siding to the southwest.
7. Condition of Resource Good
8. National Register status (estimation) unevaluated
9. Comments (including degree of development pressure and type on resource) This resource is surrounded by older residential development and is zoned C-2 (Highway Commercial). Under pressure.

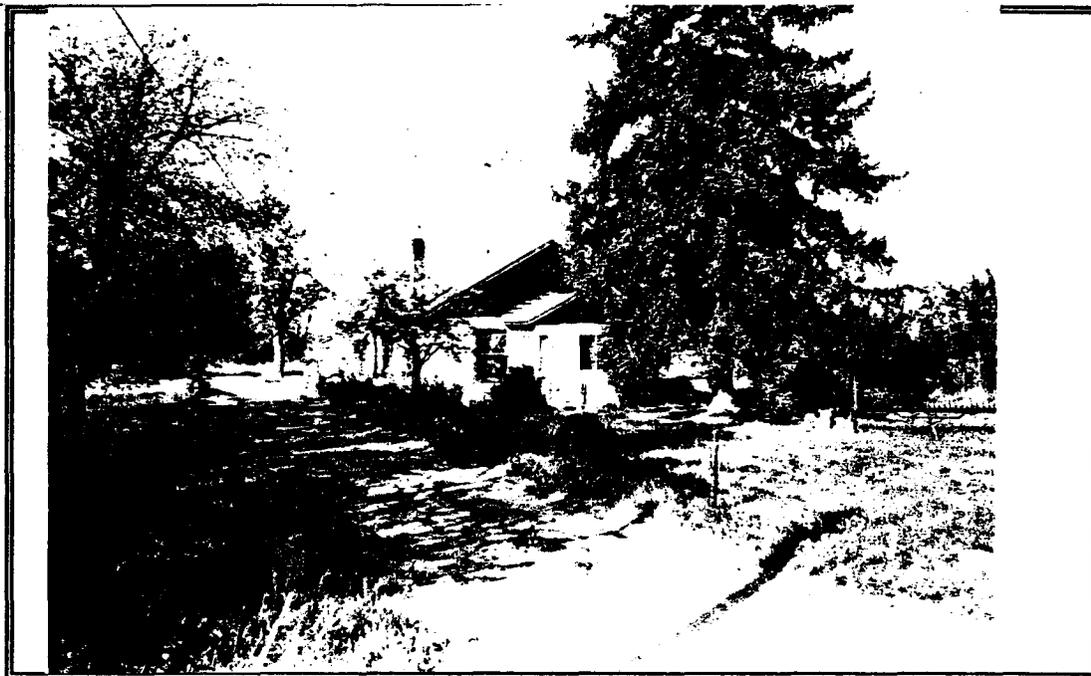
1. Inventory # 047
2. Historic and/or common name (if known) _____
3. Address of resource 7473 W. State Street
4. Township Survey Data
NE 1/4 of NW 1/4 of SE 1/4 of Section 24 T4N R1E Boise-Meridian
5. Use/type classification Domestic
6. General Architectural description 1 1/2 story wood frame Bungalow. Gable roof with projecting enclosed gable roofed porch. Rear Shed roof addition. Stucco with shingles in gable ends. Bay window at east. 1/1 double hung windows.
7. Condition of Resource Good
8. National Register status (estimation) unevaluated
9. Comments (including degree of development pressure and type on resource) There is agricultural land to the south. Development of that area would impact this site. Under pressure. Zoned R1.

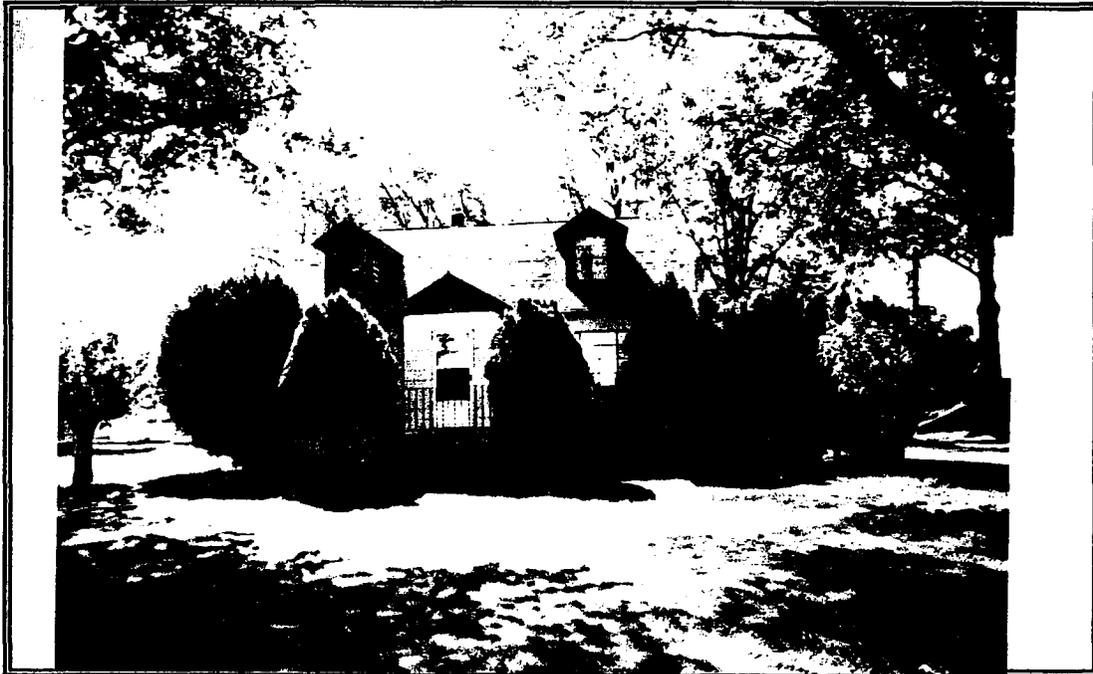
7. Condition of Resource Good
8. National Register status (estimation) unevaluated
9. Comments (including degree of development pressure and type on resource) This site was part of a large farm extending to the river. It is surrounded by commercial and residential development. Commercial zoning may impact this site. Under pressure with potential threat. Zoned C-1 (Neighborhood Commercial). (Interview with owner 5/12/92)

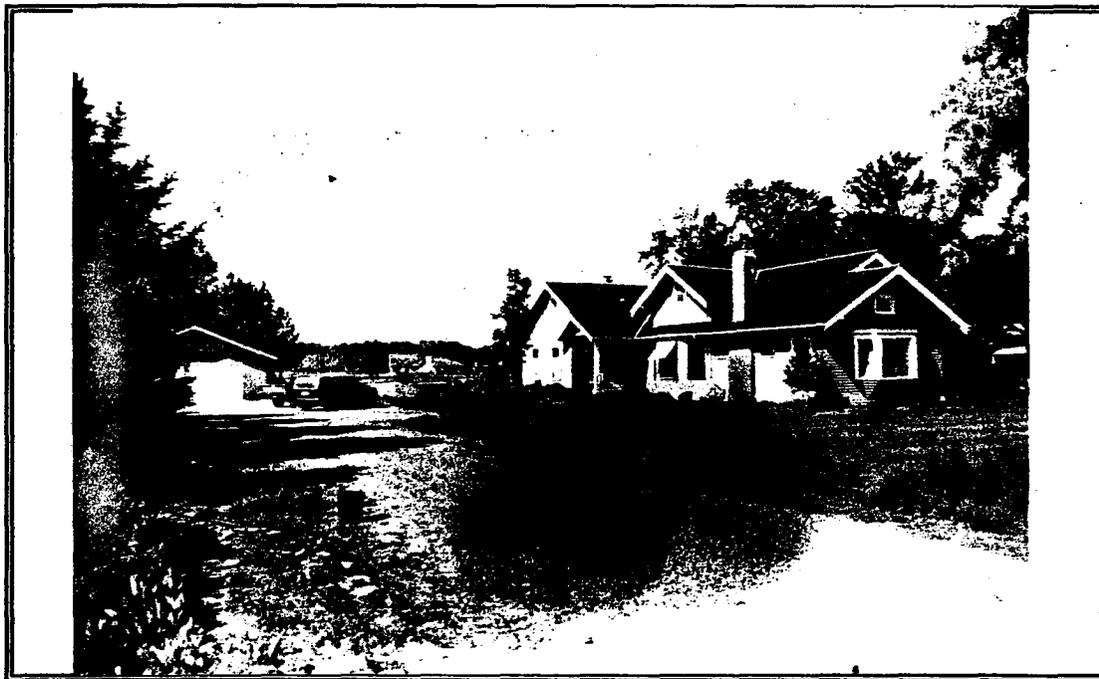
7. Condition of Resource Good
8. National Register status (estimation) not eligible
9. Comments (including degree of development pressure and type on resource) This structure was moved here 18 years ago. Considerable alterations have occurred. The area around the property is being developed for residential neighborhoods. Traffic has increased dramatically (Interview with owner 5/12/92) Under pressure. Zoned AP-2.

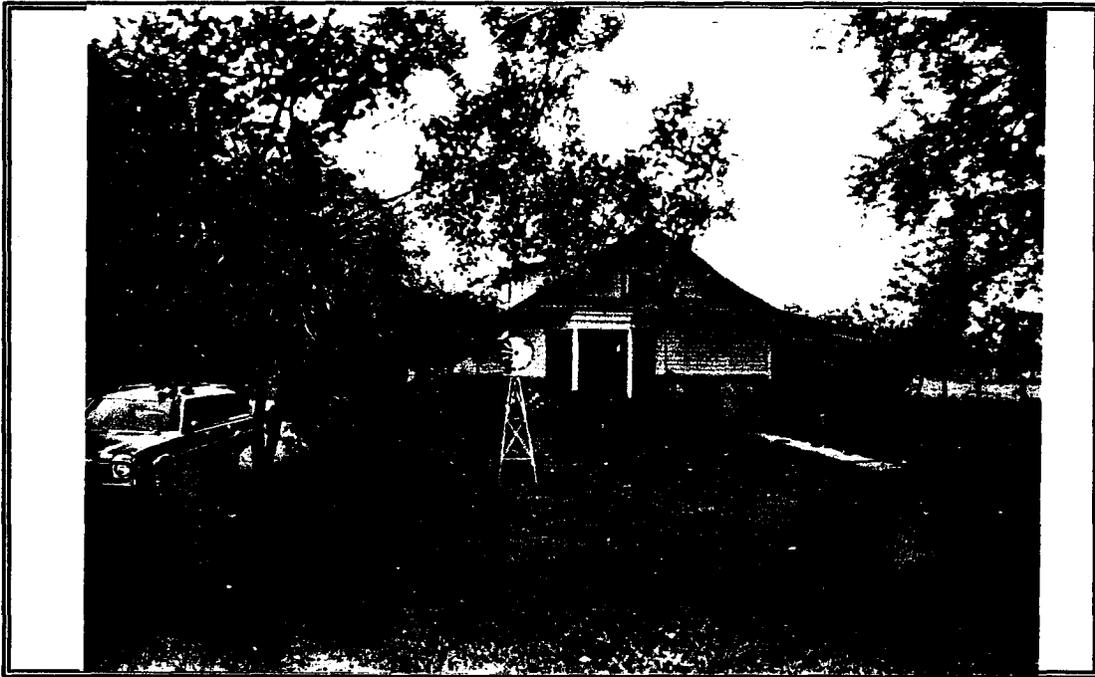
1. Inventory # 053
2. Historic and/or common name (if known) _____
3. Address of resource 6220 Roe Street
4. Township Survey Data
NW 1/4 of NE 1/4 of NW 1/4 of Section 24 T4N R1E Boise-Meridian
5. Use/type classification Domestic
6. General Architectural description 1 1/2 story, wood frame, Bungalow. Gable roof with shed dormer, exposed rafter ends and decorative brackets. Shiplap siding with newer stone veneer at the base. Addition to the south and east. 2 stall flat roof garage/shed.
7. Condition of Resource Good
8. National Register status (estimation) unevaluated
9. Comments (including degree of development pressure and type on resource) This site is bordered by pasture land on the south and east. Residential development in this area would impact the site. Zoned R1, surrounded by AP-2. Under pressure.

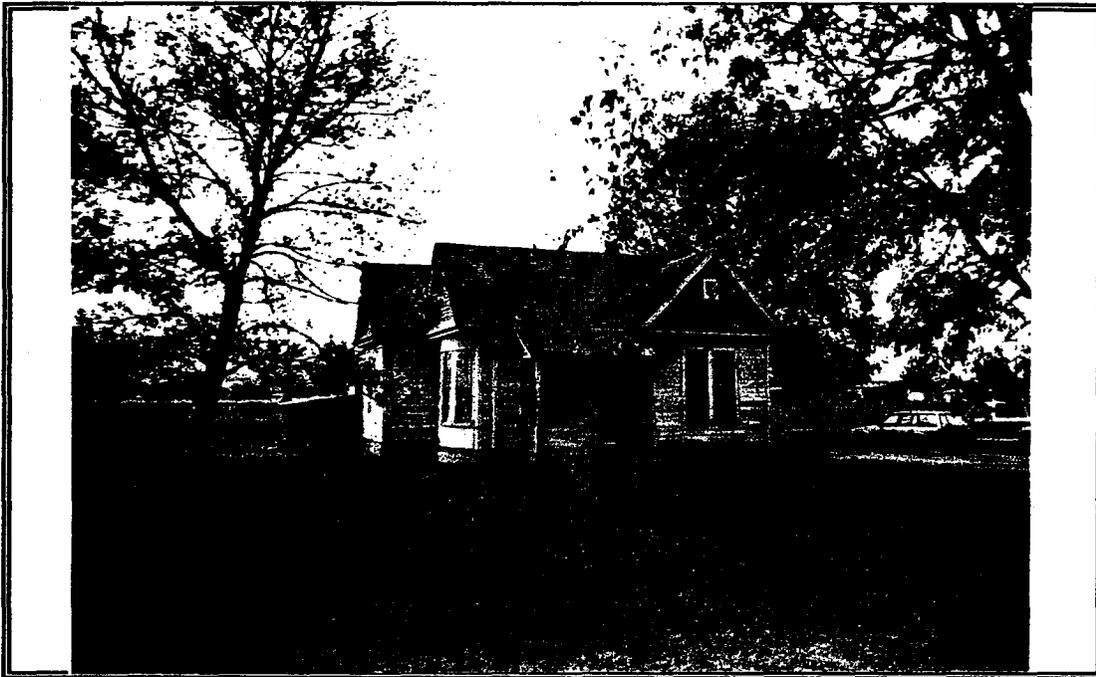
Photo 03/04

1. Inventory # 054
2. Historic and/or common name (if known) _____
3. Address of resource 6450 Roe Street
4. Township Survey Data
SW 1/4 of SE 1/4 of SW 1/4 of Section 13 T4N R1E Boise-Meridian
5. Use/type classification Domestic
6. General Architectural description 1 1/2 story, wood frame, Queen Anne Style Residence. Shiplap siding with decorative cut shingles in the gable ends. 1/1 double hung windows. Bay window at north. Open porch with turned posts. Shed roof addition to the east.
7. Condition of Resource Good
8. National Register status (estimation) unevaluated
9. Comments (including degree of development pressure and type on resource) This resource is surrounded by agricultural land to the east and south. Residential development will impact this property. Zoned R1 surrounded by AP-2. Under pressure.

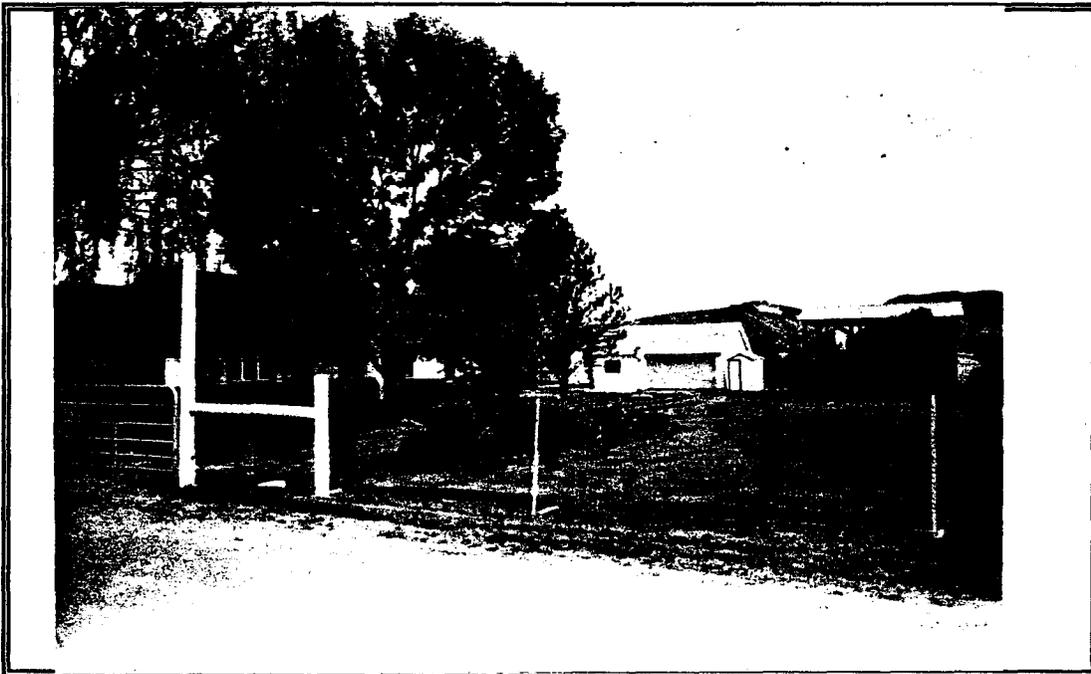
5. Use/type classification Domestic/Agricultural
6. General Architectural description 1 1/2 story, wood frame, gable roof, former Bungalow? Exterior and windows altered. Outbuildings: 1 car garage with gable roof, wide horizontal siding; garage/shed with gable roof, exposed rafter ends, shiplap siding; 3 small gable roofed sheds. 1 1/2 story gable roof barn with shed addition.

7. Condition of Resource Good
8. National Register status (estimation) unevaluated
9. Comments (including degree of development pressure and type on resource) This resource is surrounded by agricultural land on the west, north, and east. Residential development will impact this site. Zoned AP-2. Under pressure with potential threat.

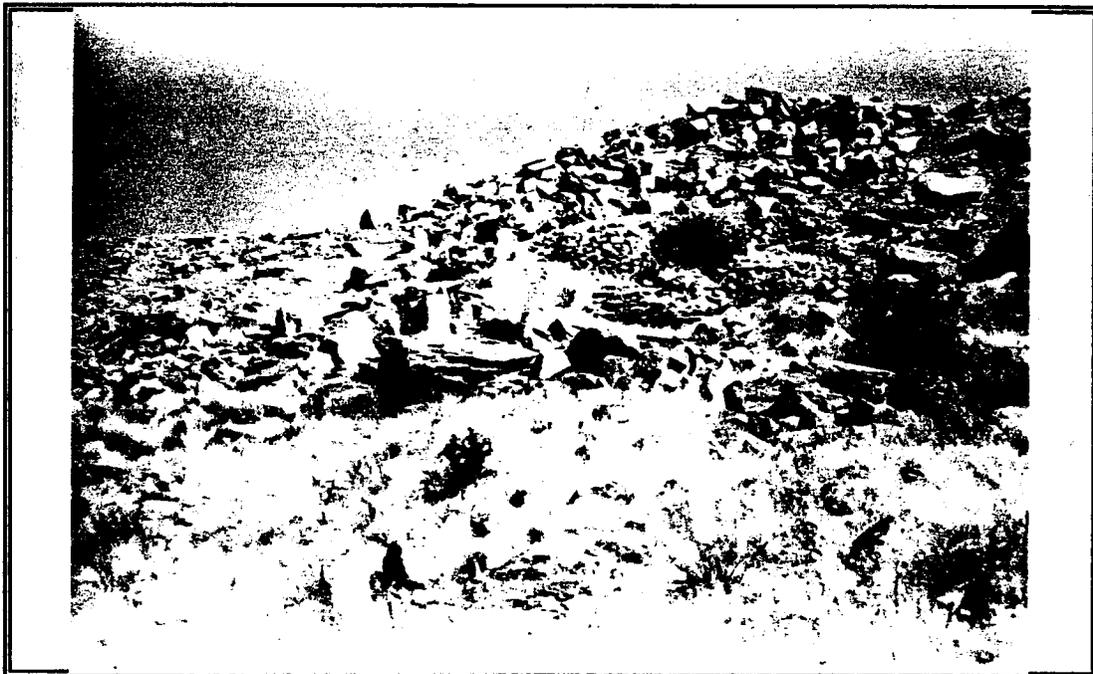
5. Use/type classification _____
6. Estimated Archaeological period Dry laid stone wall/foundation,
timbers, steel cables - part of road bed along southeast corner of
Table Rock. Historic railroad to quarry site at Table Road late 1800's
early 1900's

7. Condition of Resource deteriorated - abandoned railroad bed
8. National Register status (estimation) not eligible
9. Comments (including degree of development pressure and type on re-
source) As residential subdivision along bench southeast of Table
Rock develops, more people will be using this area and affecting
the historic evidence. Zoned AP-2 under pressure with potential
threat.
See Ada County Archaeological Survey No. 10AA105
