BOISE CITY AREA OF CITY IMPACT
WINDSHIELD SURVEY OF HISTORIC RESOURCES

August 1992

By Donna Hartmans

For Ada County Historic Preservation Council
and
Boise City Historic Preservation Council

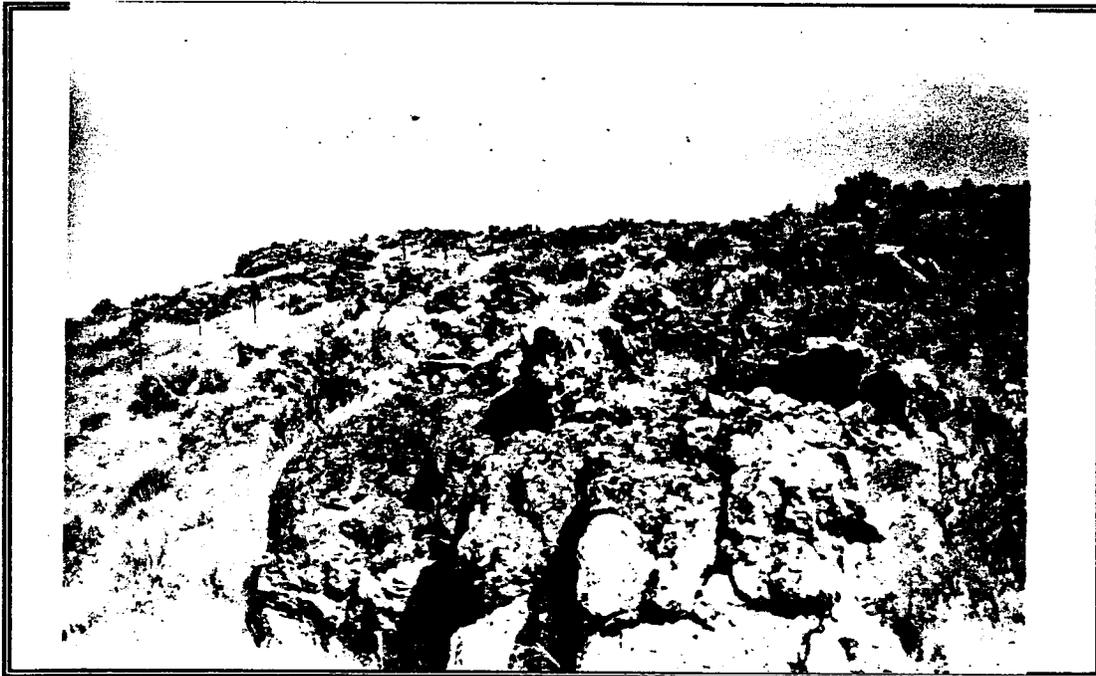
1. Inventory # 058
2. Historic and/or common name (if known) _____
3. Address of resource N/A
4. Township Survey Data
NE1/4-SE1/4 of NE1/4 of NE1/4 of Section 19 T3N R3E Boise-Meridian
5. Use/type classification _____
6. Estimated Archaeological period Rock hunting blind - See Ada County Archaeological Survey, Site No. 10AA88. Archaic Period

7. Condition of Resource good - fair
8. National Register status (estimation) unevaluated
9. Comments (including degree of development pressure and type on resource) As the residential subdivision along the bench southeast of Table Road develops, more people will be using this area and affecting the archaeological evidence. Grazing may also impact this site. See Ada County Archaeological Survey Sites Nos. 10AA87-92 for the complexity of this site which extends into Section 20, T3N, R3E. Zoned AP-2 under pressure with potential threat.

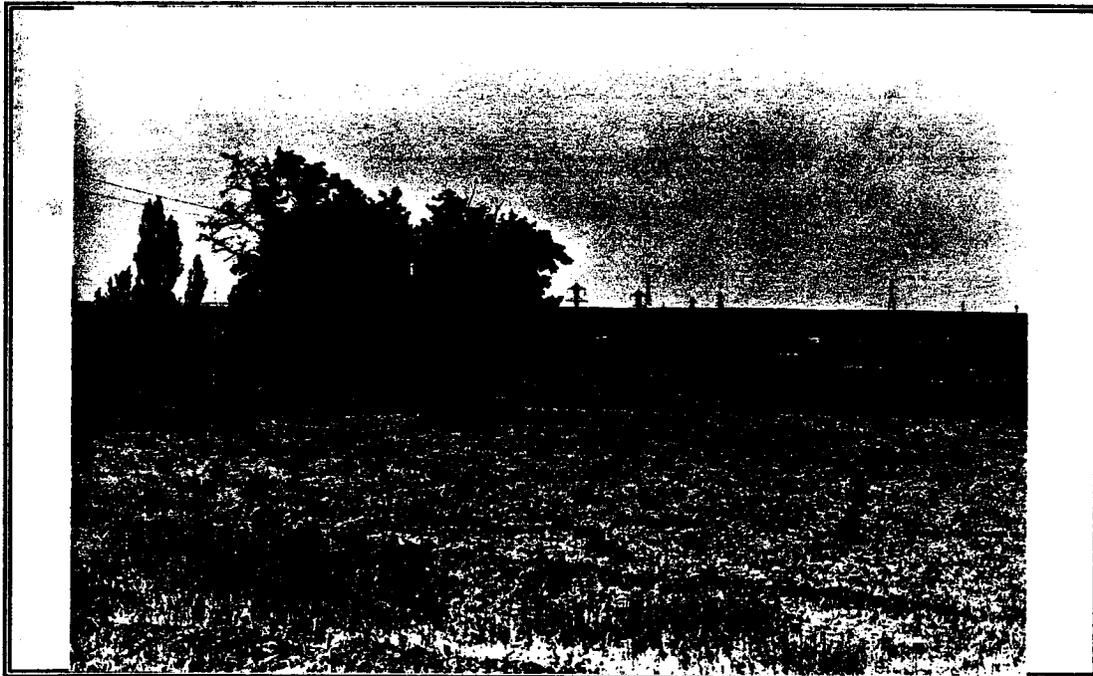
Photo 03/23

1. Inventory # 063
2. Historic and/or common name (if known) _____
3. Address of resource Highway 21 East (NW of Barber Dam)
4. Township Survey Data
NW 1/4 of NW 1/4 of SE 1/4 of Section 29 T3N R3E Boise-Meridian
5. Use/type classification Agricultural
6. General Architectural description Corralled area containing a few wood frame sheds and outbuildings.
7. Condition of Resource deteriorated - abandoned
8. National Register status (estimation) not eligible
9. Comments (including degree of development pressure and type on resource) This site is surrounded by agricultural land. Any residential development will impact the site. Zoned AP-2. Under pressure.

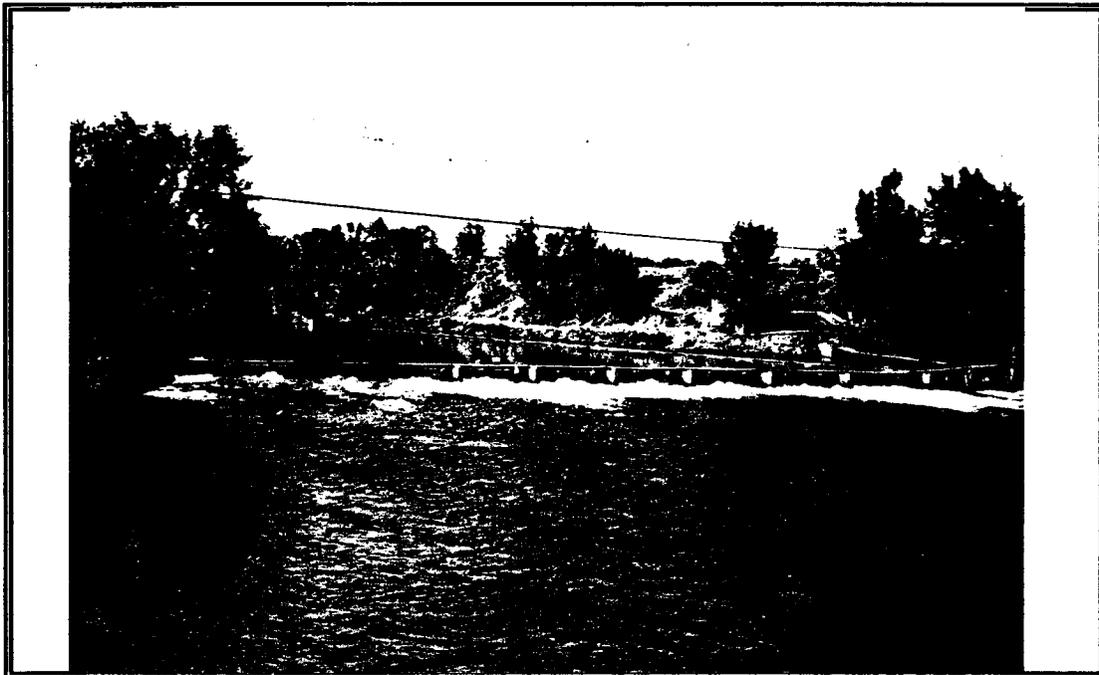
Photo 03/24-26

1. Inventory # 064
2. Historic and/or common name (if known) Ridenbaugh Dam/Irrigation Canal
3. Address of resource S. Eckert Road near Boise Ave. on Boise River
4. Township Survey Data
SW 1/4 of NW 1/4 of SW 1/4 of Section 29 T3N R3E Boise-Meridian
5. Use/type classification Engineering/Agricultural
6. General Architectural description Concrete spillway on Boise River. Canal control gate is concrete and stone. Concrete abutments remain from old bridge across canal.
7. Condition of Resource Good
8. National Register status (estimation) unevaluated
9. Comments (including degree of development pressure and type on resource) The Ridenbaugh Canal has been encroached upon by residential development as it extends westward. The extent of this dam/canal system is surrounded by a variety of zoning districts. No pressure.

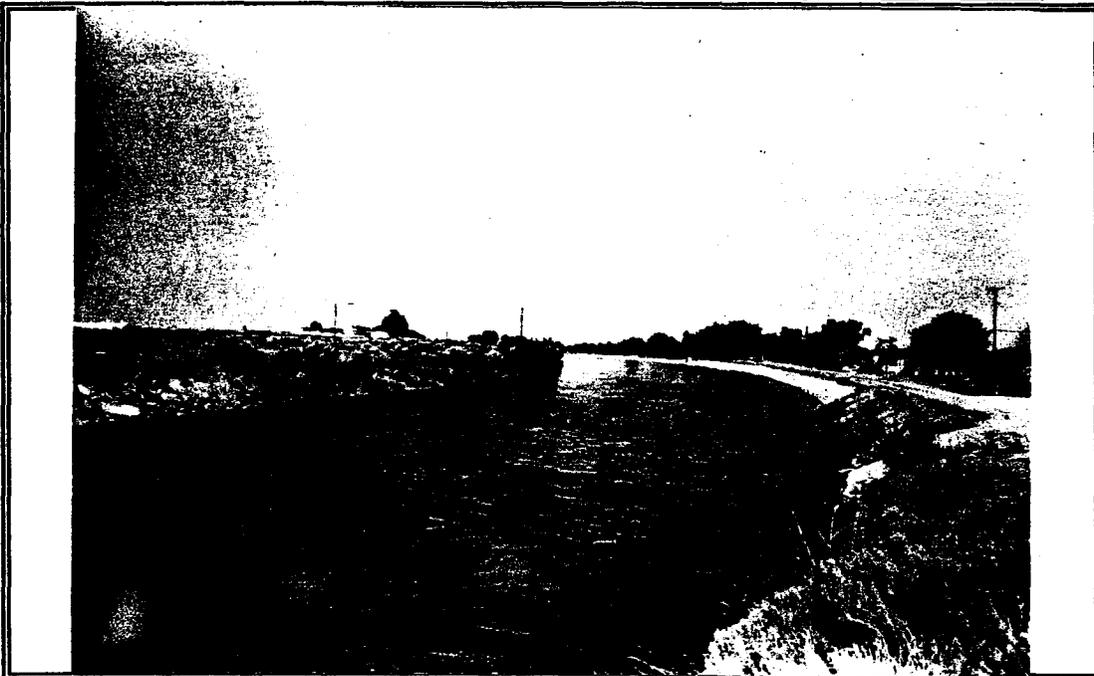
1. Inventory # 065
2. Historic and/or common name (if known) New York Canal
3. Address of resource _____
4. Township Survey Data This structure extends through the following Townships T2N R3E Section 3, 4; T3N, R3E Section 29-30, 32-33; T3N, R2E Section 20, 21, 25-32; T3N, R1E Section 25, 36; T2N, R2E, Section 6, 7; T2N, R1E Section 10-12, 15, 16, 21 Boise Meridian
5. Use/type classification Engineering/Agricultural
6. General Architectural description Concrete irrigation canal providing water for the Boise Valley.

7. Condition of Resource Excellent
8. National Register status (estimation) eligible
9. Comments (including degree of development pressure and type on resource) This structure has been encroached upon by residential development. The extent of this canal system is surrounded by a variety of zoning districts. No pressure. Also see Ada County Reconnaissance Survey 000955-56

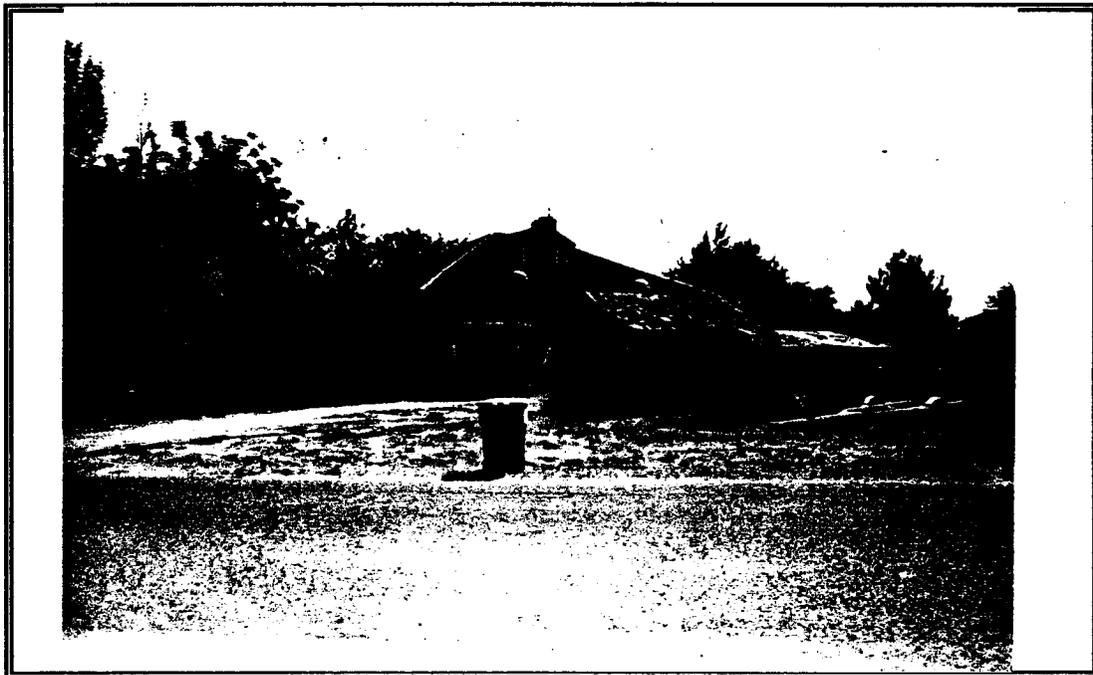
5. Use/type classification Domestic
6. General Architectural description 1 1/2 story brick-common bond. Hip roof. Concrete lintels and sills at doors and windows. Double front doors. 1/1 double hung windows. Gable dormers added to north and south. Front porch replaced with deck. Small greenhouse addition on southwest corner. Outbuildings: Gable roofed garage with narrow lap siding and cornerboards. 2 small sheds with shed roofs, narrow lap siding and cornerboards.

7. Condition of Resource Good
8. National Register status (estimation) unevaluated
9. Comments (including degree of development pressure and type on resource) This property is surrounded by residential development already. Widening Boise Avenue would impact the site. Zoned R8. Potential threat.
